## Expertise

Protocol number: 46072888  
Order No. / Reference: 26520980  
Inspection date: 18 Jun 2026

Manufacturer: Renault

Model: Trafic ENERGY dCi 120 L1H1 3.0t Komfort

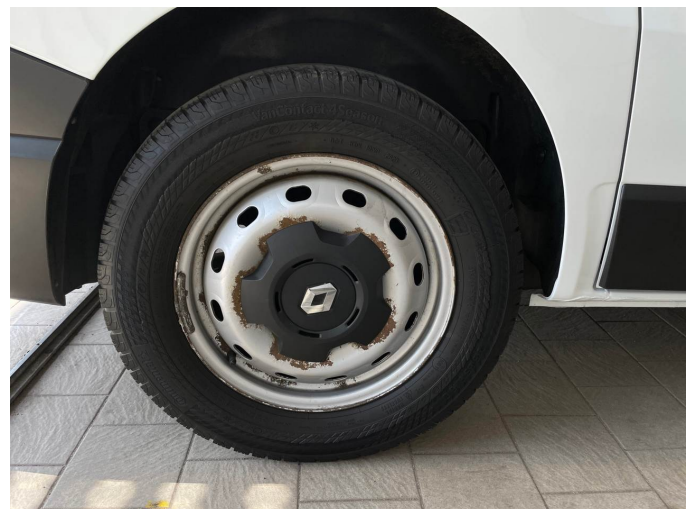
Figure 12: Mounted tyres

#	Tyre size	Type of tyre	Manufacturer	Tread depth
1)	215/65 R16 109T	Summer tyres on Steel	Michelin	6mm / 6mm
2)	215/65 R16 107T	Summer tyres on Steel	Continental	4mm / 4mm
