Expertise

Protocol number: 46193298
Order No. / Reference: 26519093
Inspection date: 19 Jun 2026

Manufacturer: Citroën

Model: e-C4 136 FEEL PACK

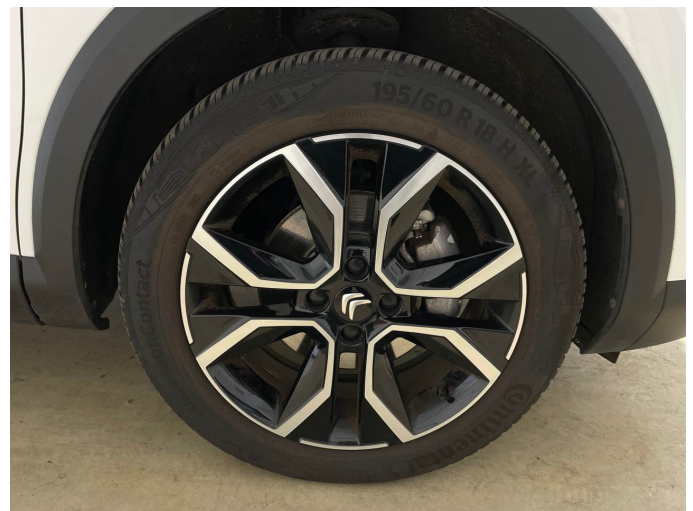
Figure 12: Mounted tyres

#	Tyre size	Type of tyre	Manufacturer	Tread depth
1)	195/60 R18 96H	All-season tyres on Light alloy	Continental	7mm / 7mm
2)	195/60 R18 96H	All-season tyres on Light alloy	Continental	7mm / 7mm
