Expertise

Protocol number: 45786733
Order No. / Reference: 25933805
Inspection date: 1 Jun 2026

Model: Vito 116 CDI Tourer Lang Aut. PRO

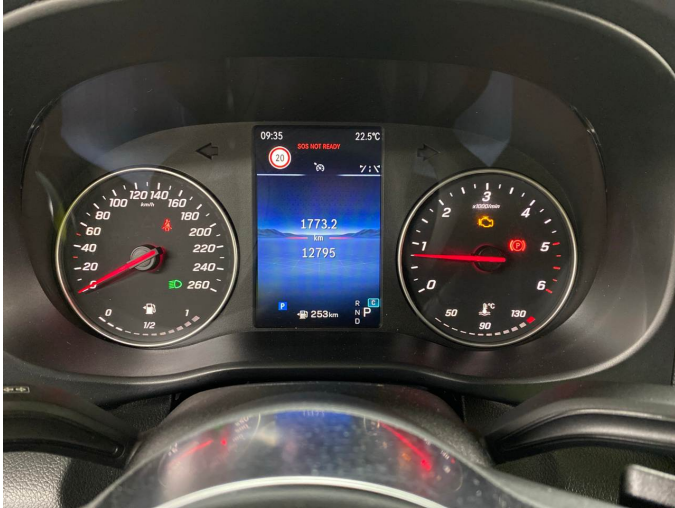
Figure 7: Instrument cluster

Documents submitted	At the time of the inspection, the vehicle registration certificate Part 2 (title) was available, but the vehicle registration certificate Part 1 (document) was not. (Copy)
VIN comparison	The vehicle identification number (VIN) was read from the vehicle and its conformity with the submitted documents was confirmed by the undersigned during the inspection.
Inspection	The inspection conditions were sufficient for the assessment of the vehicle. No lifting equipment or pit was available for inspecting the vehicle. Therefore, inspection of the vehicle's underside was only possible to a limited extent.
Test drive	No test drive/shunting maneuver was carried out during the inspection of the vehicle.
Engine function test	An engine test run was performed, problem has been detected This is due to the following reason.: Motorkontrolle aktiv

Damage 3: Instrument panel: Indicator light (Motorkontrolle) - on - Perform diagnosis
