Expertise

Protocol number: 46487319  
Order No. / Reference: 26663508  
Inspection date: 9 Jul 2026

Manufacturer: Volkswagen

Model: Passat Variant 1.4 TSI Plug-In-Hybrid DSG GTE

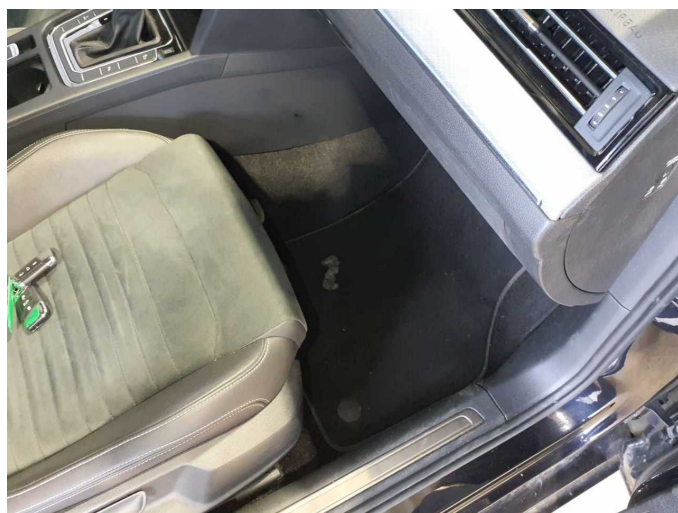
| No. | Component group | Description |
|---|---|---|
| 1 | Trim / covers | Floor mats - Broken / torn - Replace |

**Damage 1:** Trim / covers: Floor mats - Broken / torn - Replace

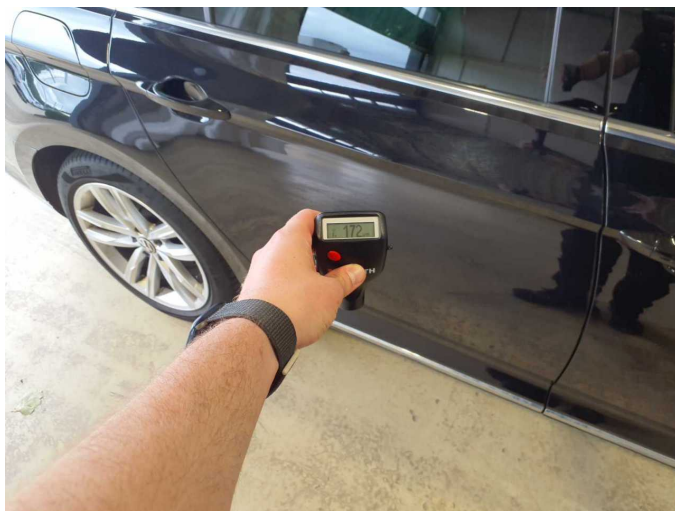
| No. | Repainting |
|---|---|
| 2 | Door - rear right side, Professionally carried out, Invoice of repair done Non-existent |

**Repainting 2:** Door - rear right side
