## Expertise

Protocol number: 46347990  
Order No. / Reference: 26185550  
Inspection date: 2 Jul 2026

Manufacturer: Mercedes-Benz

Model: Vito 116 CDI Extralang HA Aut. PRO

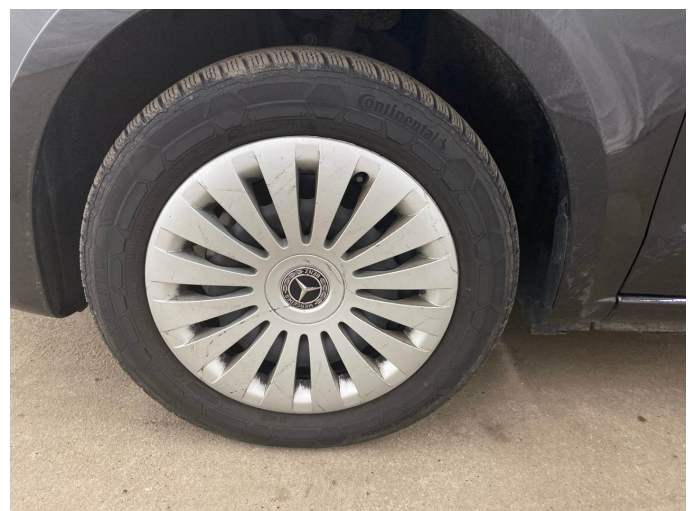
Figure 12: Mounted tyres

#	Tyre size	Type of tyre	Manufacturer	Tread depth
1)	225/55 R17 109T	Winter tyres on Steel rim with wheel cover	Continental	7mm / 7mm
2)	225/55 R17 109T	Winter tyres on Steel rim with wheel cover	Continental	6mm / 6mm
