Expertise

Protocol number: 46273969  
Order No. / Reference: 26631105  
Inspection date: 30 Jun 2026

Manufacturer: Skoda  
VIN: TMBJG7NX4MY121653

Model: Octavia Combi 2.0 TDI Style

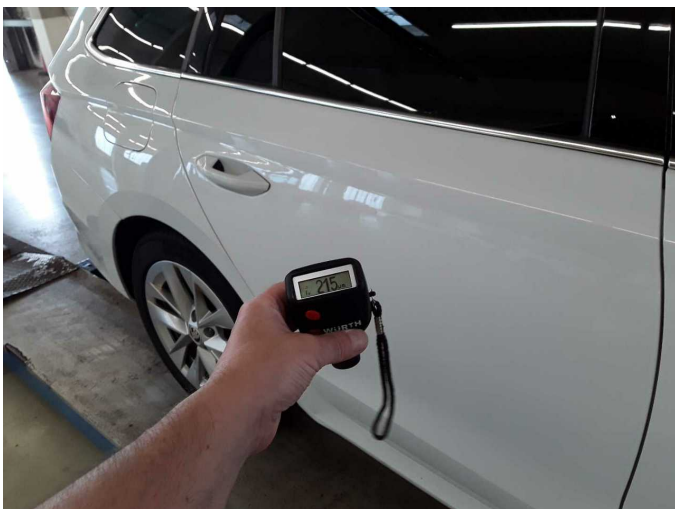
- 1 Roof rail - right side, Side panel - rear left side, Side panel - rear right side, Door - rear right side, Professionally carried out, Invoice of repair done Non-existent

**Repainting 1:** Roof rail - right side, Side panel - rear left side, Side panel - rear right side, Door - rear right side

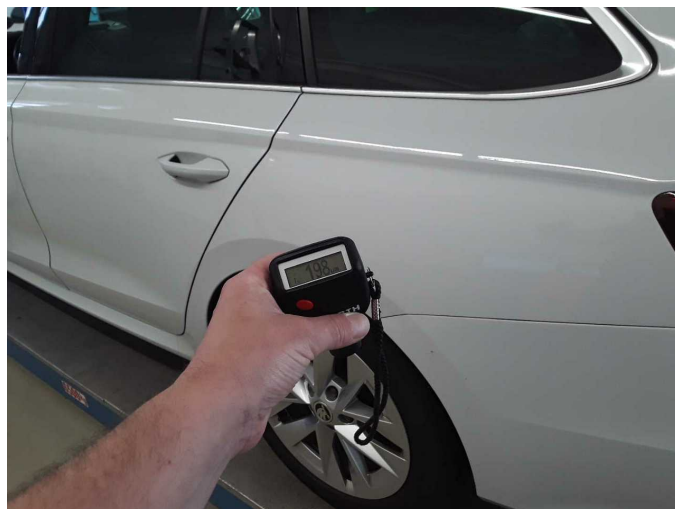
**Side panel - rear left side: 198  $\mu\text{m}$**
