Expertise

Protocol number: 46106675
Order No. / Reference: 26558607
Inspection date: 23 Jun 2026

Manufacturer: Renault

Model: Twingo Electric ZEN

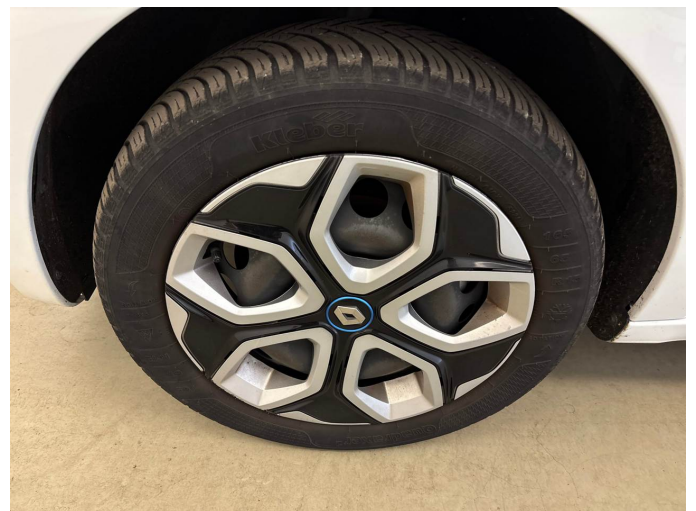
Figure 12: Mounted tyres

#	Tyre size	Type of tyre	Manufacturer	Tread depth
1)	165/65 R15 81T	All-season tyres on Steel rim with wheel cover	Kleber	3mm / 3mm
2)	185/60 R15 84T	All-season tyres on Steel rim with wheel cover	Kleber	5mm / 5mm

No.	Component group	Description
1	Gearbox	Gear knob - Damaged - Replace
2	Rear bumper	Rear bumper - Scratch(es) - Smart repair
3	Wheel / tyres	Tyre - front (Rechts und links) - Does not meet the leasing specifications - Replace
4	Body	Body - Glued / labelled - De-glue / neutralise
5	Misc.	Inspection / maintenance - Due - Perform
