Expertise

Protocol number: 45799602
Order No. / Reference: 26327123
Inspection date: 22 May 2026

Manufacturer: Volkswagen

Model: Passat Variant 2.0 TDI SCR DSG Business

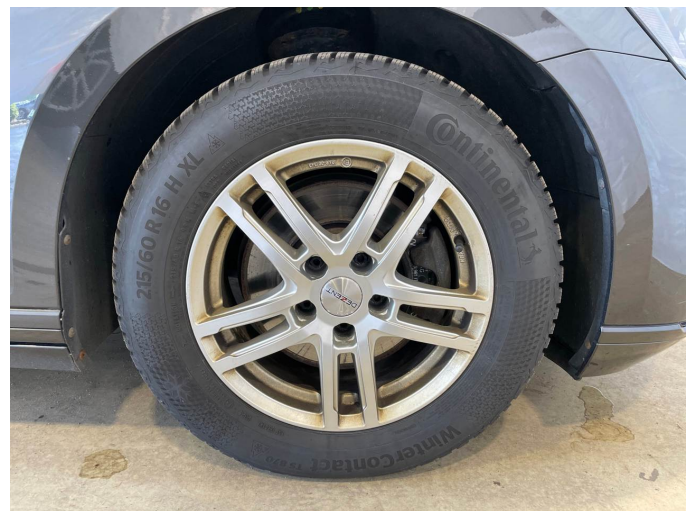
Figure 12: Mounted tyres

Mounted tyres				
#	Tyre size	Type of tyre	Manufacturer	Tread depth
1)	215/60 R16 99H	Winter tyres on Light alloy	Continental	6mm / 6mm
2)	215/60 R16 99H	Winter tyres on Light alloy	Continental	6mm / 6mm
Additional tyres				
#	Tyre size	Type of tyre	Manufacturer	Tread depth
1)	215/60 R16 95V	Summer tyres on Light alloy	Continental	3mm / 3mm
2)	215/60 R16 95V	Summer tyres on Light alloy	Continental	3mm / 3mm
Replacement				
Typ	Tyre size	Type of tyre	Manufacturer	Tread depth
	Tirefit	Expiration date 04/2025
