Expertise

Protocol number: 45990728
Order No. / Reference: 26603802
Inspection date: 17 Jun 2026

Model: Caddy 2.0 TDI BMT (5-Si.) 4MOTION Caddy

VIN: WV2ZZZSKZNX058822

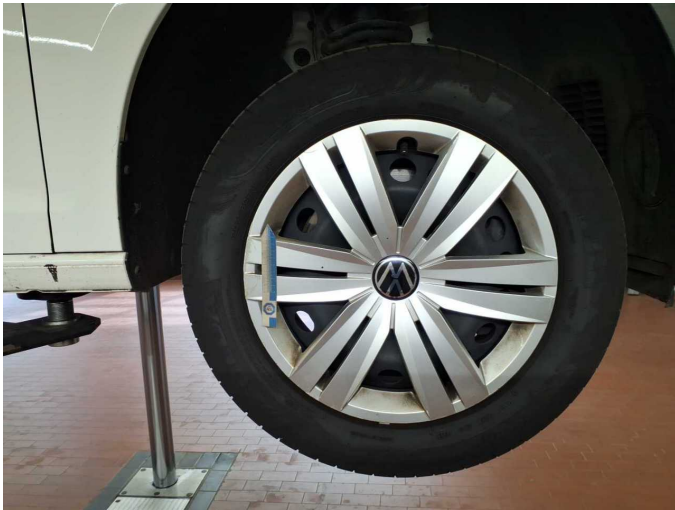
| No. | Component group | Description |
|---|---|---|
| 1 | Wheel / tyres | Wheel cover - front right side - Scratched - Replace |

Damage 1: Wheel / tyres: Wheel cover - front right side - Scratched - Replace
