Expertise

Protocol number: 45512998
Order No. / Reference: 26384463
Inspection date: 19 May 2026

Model: Astra 1.5 D Automatik Ultimate

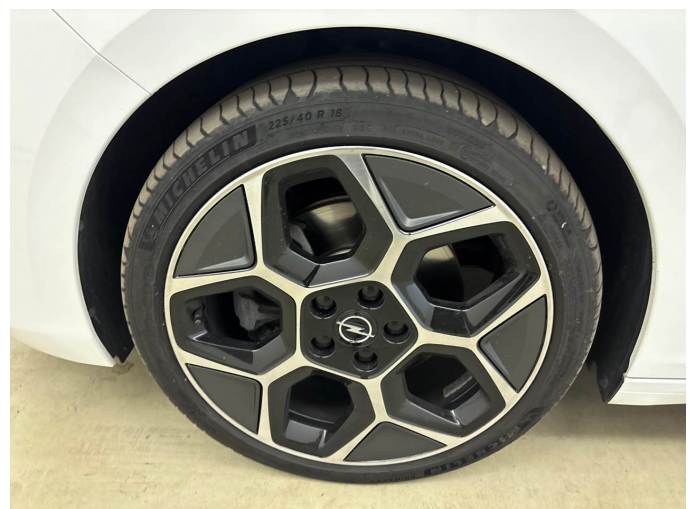
Figure 12: Mounted tyres

#	Tyre size	Type of tyre	Manufacturer	Tread depth
1)	225/40 R18 92Y	Summer tyres on Light alloy	Michelin	4mm / 4mm
2)	225/40 R18 92Y	Summer tyres on Light alloy	Michelin	4mm / 4mm
