Expertise

Protocol number: 46139819  
Order No. / Reference: 26484122  
Inspection date: 16 Jun 2026

Manufacturer: Skoda  
VIN: TMBJF9NU3PC213679

Model: Karoq 2.0 TDI SCR DSG Style

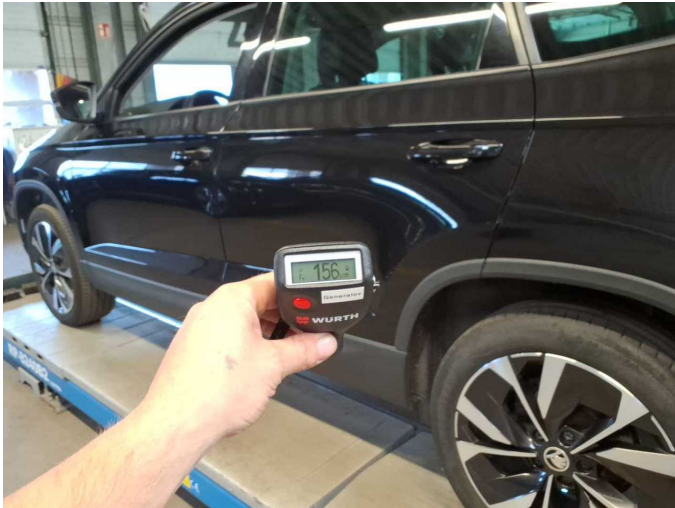
| No. | Repainting |
|---|---|
| 7 | Door - rear left side, Professionally carried out, Invoice of repair done Non-existent |

**Repainting 7:** Door - rear left side
