Expertise

Protocol number: 46289191
Order No. / Reference: 26627660
Inspection date: 2 Jul 2026

Manufacturer: Opel

Model: Insignia Sports Tourer 2.0 Diesel Aut. Business Edition

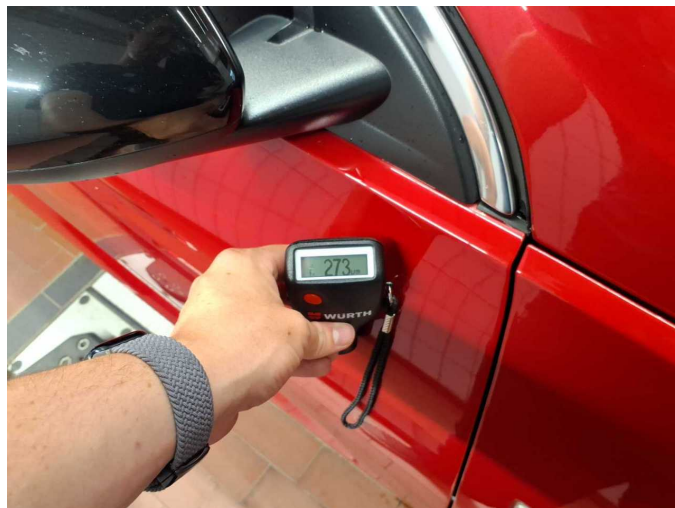
Repainting 6: Door - front right side
