Expertise

Protocol number: 46161754
Order No. / Reference: 26485253
Inspection date: 24 Jun 2026

Model: SANTA FE 1.6 Plugin-Hybrid 4WD Signature

VIN: KMHS4812DNU044458

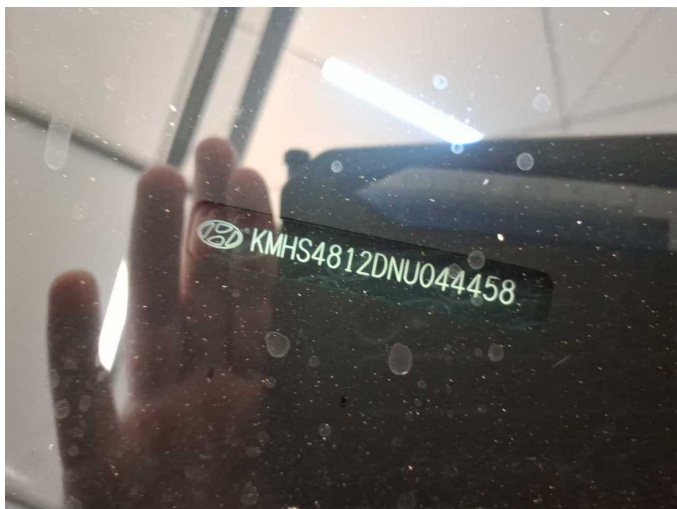
Figure 11: VIN

Documents submitted	At the time of the inspection, the vehicle registration certificate Part 2 (title) was available, but the vehicle registration certificate Part 1 (document) was not. (Copy)
VIN comparison	The vehicle identification number (VIN) was read from the vehicle and its conformity with the submitted documents was confirmed by the undersigned during the inspection.
Inspection	The inspection conditions were sufficient for the assessment of the vehicle. No lifting equipment or pit was available for inspecting the vehicle. Therefore, inspection of the vehicle's underside was only possible to a limited extent.
Test drive	No test drive/shunting maneuver was carried out during the inspection of the vehicle.
Engine function test	An engine test run was performed.
readiness to drive	The vehicle was roadworthy at the time of inspection.

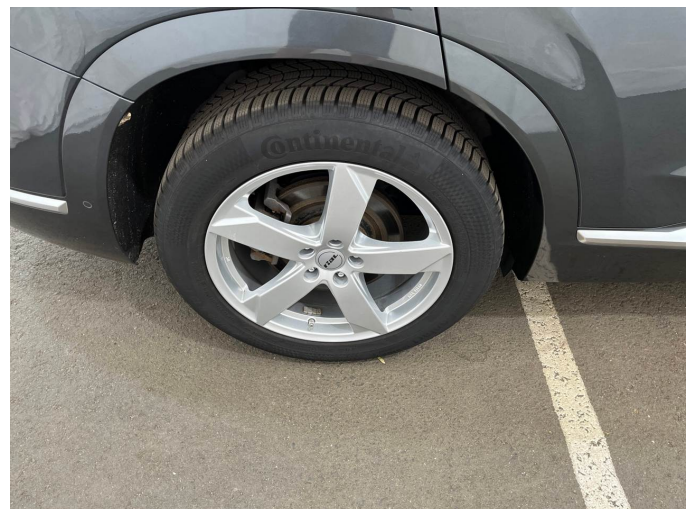
Figure 12: Mounted tyres

#	Tyre size	Type of tyre	Manufacturer	Tread depth
1)	235/55 R19 105H	Winter tyres on Light alloy	Continental	6mm / 6mm
2)	235/55 R19 105H	Winter tyres on Light alloy	Continental	7mm / 7mm

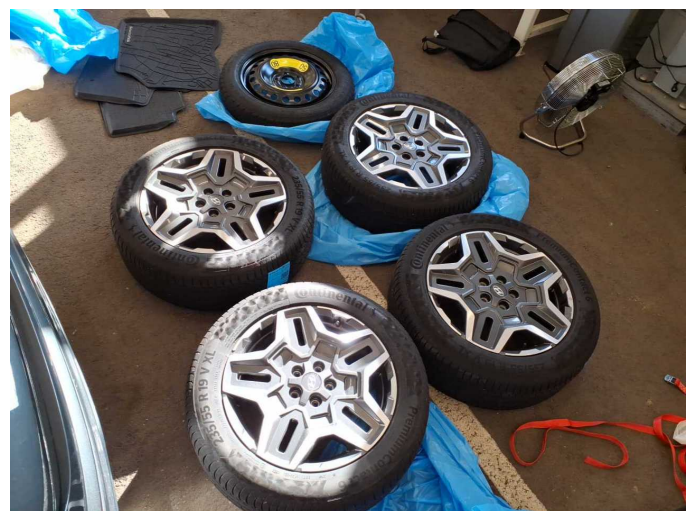
Figure 18: Additional tyres

Typ	Tyre size	Type of tyre	Manufacturer	Tread depth
N	135/90 R17 104M	Summer tyres on Steel	Kumho	4 mm
	Tirefit	Expiration date 09/2026
