## Expertise

Protocol number: 46152819  
Order No. / Reference: 26538920  
Inspection date: 25 Jun 2026

Model: Focus Turnier 1.5 EcoBlue Start-Stopp-System Aut. TITANIUM

VIN: WF0PXXGCHPPE77016

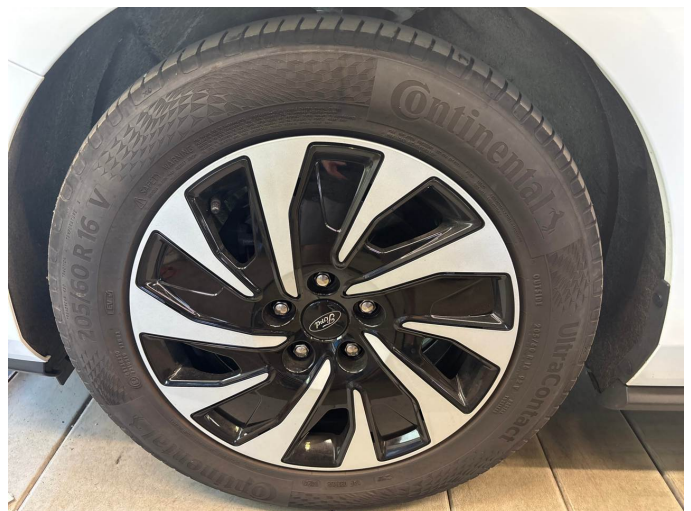
Figure 12: Mounted tyres

Mounted tyres				
#	Tyre size	Type of tyre	Manufacturer	Tread depth
1)	205/60 R16 92V	Summer tyres on Light alloy	Continental	4mm / 4mm
2)	205/60 R16 92V	Summer tyres on Light alloy	Continental	4mm / 4mm
Replacement				
Typ	Tyre size	Type of tyre	Manufacturer	Tread depth
N	125/70 R16 96M	Summer tyres on Steel	Hankook	2 mm
