Expertise

Protocol number: 46004139
Order No. / Reference: 26451761
Inspection date: 16 Jun 2026

Manufacturer: Opel

Model: Vivaro 2.0 D Cargo L EHZ Autm. Elegance

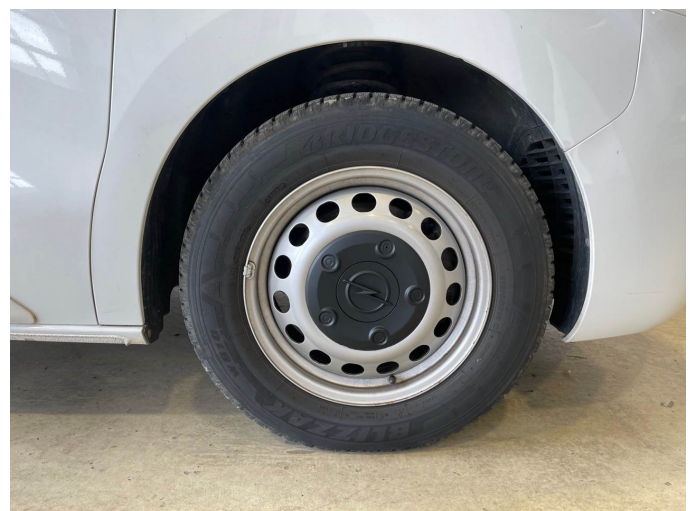
Figure 12: Mounted tyres

#	Tyre size	Type of tyre	Manufacturer	Tread depth
1)	215/65 R16 109T	Winter tyres on Steel	Bridgestone	5mm / 5mm
2)	215/65 R16 109T	Winter tyres on Steel	Bridgestone	7mm / 7mm

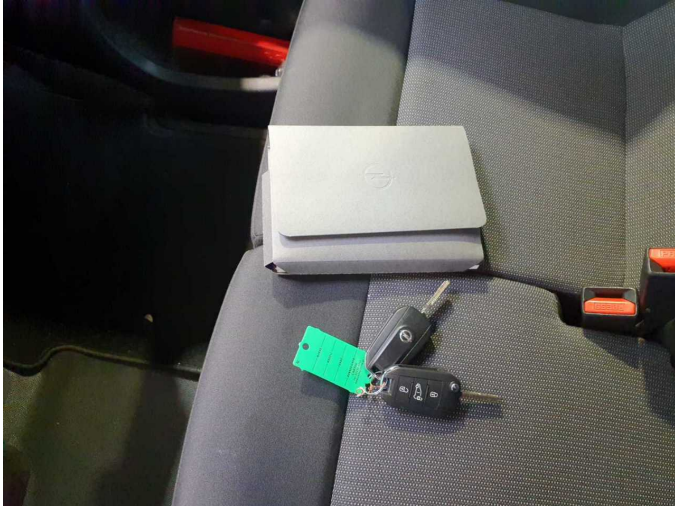
Figure 13: Documents

Documents submitted	At the time of the inspection, the vehicle registration certificate Part 2 (title) was available, but the vehicle registration certificate Part 1 (document) was not. (Copy)
VIN comparison	The vehicle identification number (VIN) was read from the vehicle and its conformity with the submitted documents was confirmed by the undersigned during the inspection.
Inspection	The inspection conditions were sufficient for the assessment of the vehicle. Lifting equipment and/or a pit were available for examining the vehicle.
Test drive	No test drive/shunting maneuver was carried out during the inspection of the vehicle.
Engine function test	An engine test run was performed.

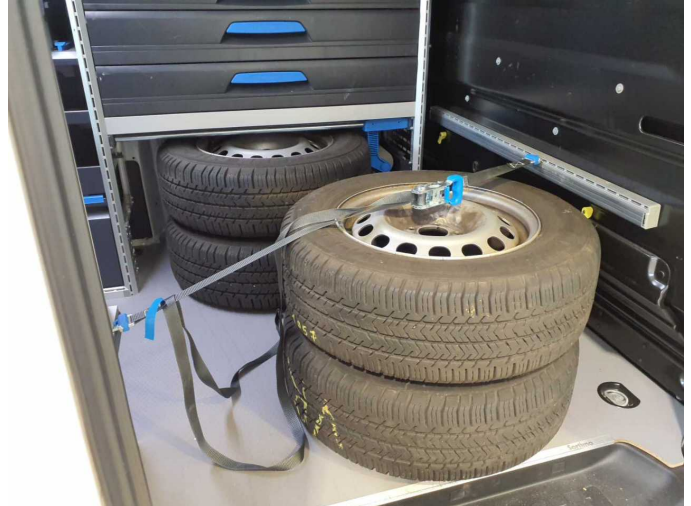
Figure 14: Additional tyres

#	Tyre size	Type of tyre	Manufacturer	Tread depth
1)	215/65 R16 106T	Summer tyres on Steel	Michelin	7mm / 7mm
2)	215/65 R16 106T	Summer tyres on Steel	Michelin	8mm / 8mm
