Expertise

Protocol number: 46740280  
Order No. / Reference: 26804302  
Inspection date: 27 Jul 2026

Manufacturer: Volkswagen

Model: Transporter T6.1 4MOTION Lang

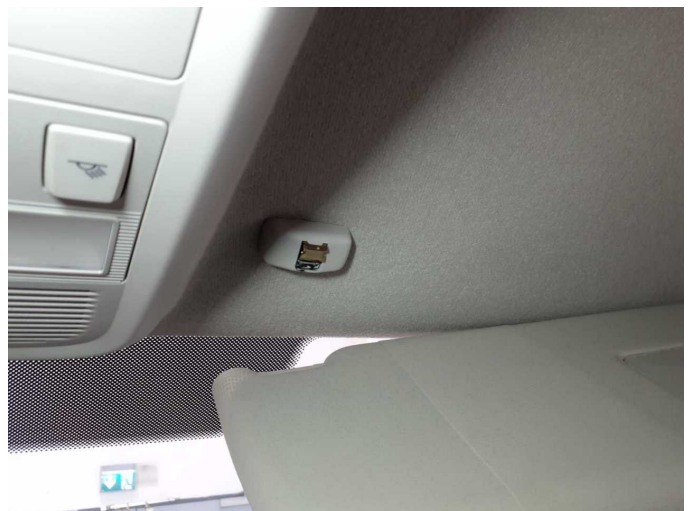
| No. | Component group | Description |
|---|---|---|
| 1 | Interior | Sun visor - right side (Halter) - Broken / torn - Perform |

**Damage 1:** Interior: Sun visor - right side (Halter) - Broken / torn - Perform
