Expertise

Protocol number: 46269172
Order No. / Reference: 26461196
Inspection date: 1 Jul 2026

Model: Kodiaq 2.0 TDI 4x4 DSG Style

VIN: TMBLJ7NS6P8032606

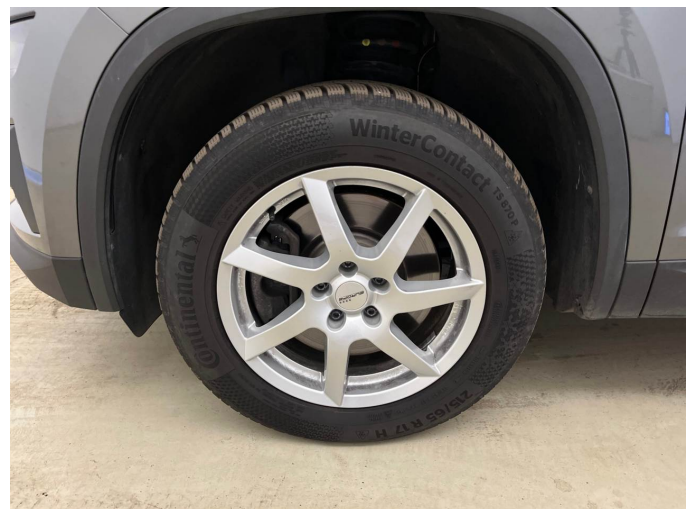
Figure 12: Mounted tyres

#	Tyre size	Type of tyre	Manufacturer	Tread depth
1)	215/65 R17 99H	Winter tyres on Light alloy	Continental	5mm / 5mm
2)	215/65 R17 99H	Winter tyres on Light alloy	Continental	6mm / 5mm

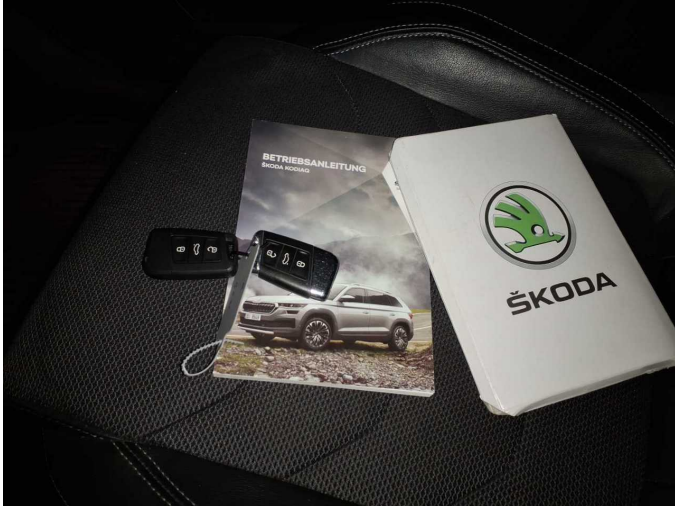
Figure 13: Documents

Documents submitted	At the time of the inspection, the vehicle registration certificate Part 2 (title) was available, but the vehicle registration certificate Part 1 (document) was not. (Copy)
VIN comparison	The vehicle identification number (VIN) was read from the vehicle and its conformity with the submitted documents was confirmed by the undersigned during the inspection.
Inspection	The inspection conditions were sufficient for the assessment of the vehicle. Lifting equipment and/or a pit were available for examining the vehicle.
Test drive	No test drive/shunting maneuver was carried out during the inspection of the vehicle.
Engine function test	An engine test run was performed.

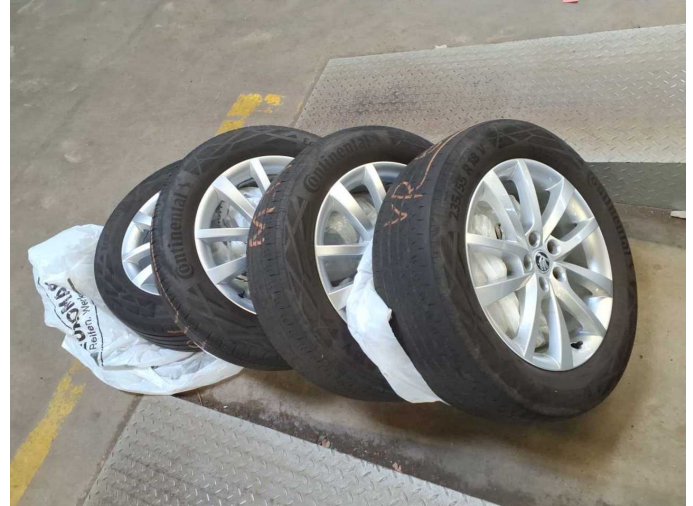
Figure 14: Additional tyres

#	Tyre size	Type of tyre	Manufacturer	Tread depth
1)	235/55 R18 100V	Summer tyres on Light alloy	Continental	3mm / 3mm
2)	235/55 R18 100V	Summer tyres on Light alloy	Continental	4mm / 4mm
