Expertise

Protocol number: 46193234
Order No. / Reference: 26151800
Inspection date: 21 May 2026

Manufacturer: Mercedes-Benz

Model: Vito 116 CDI Extralang HA Aut. PRO

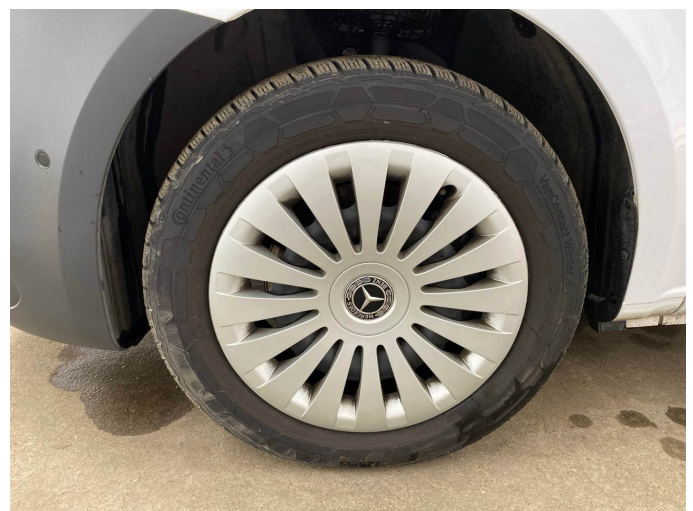
Figure 12: Mounted tyres

#	Tyre size	Type of tyre	Manufacturer	Tread depth
1)	225/55 R17 109T	Winter tyres on Steel rim with wheel cover	Continental	6mm / 6mm
2)	225/55 R17 109T	Winter tyres on Steel rim with wheel cover	Continental	6mm / 6mm

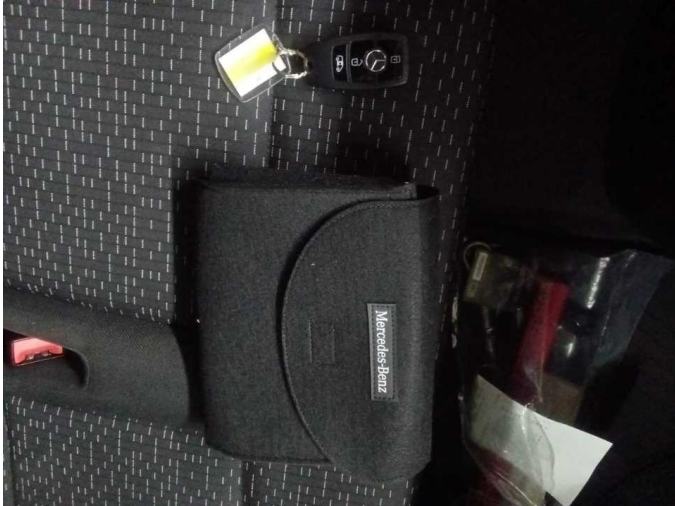
Figure 13: Documents

Documents submitted	At the time of the inspection, the vehicle registration certificate Part 2 (title) was available, but the vehicle registration certificate Part 1 (document) was not. (Copy)
VIN comparison	The vehicle identification number (VIN) was read from the vehicle and its conformity with the submitted documents was confirmed by the undersigned during the inspection.
Inspection	The inspection conditions were sufficient for the assessment of the vehicle. Lifting equipment and/or a pit were available for examining the vehicle.
Test drive	No test drive/shunting maneuver was carried out during the inspection of the vehicle.
Engine function test	An engine test run was performed.
