## Expertise

Protocol number: 45689421  
Order No. / Reference: 26414751  
Inspection date: 28 May 2026

Manufacturer: Seat

Model: Leon 2.0 TDI DSG FR Plus

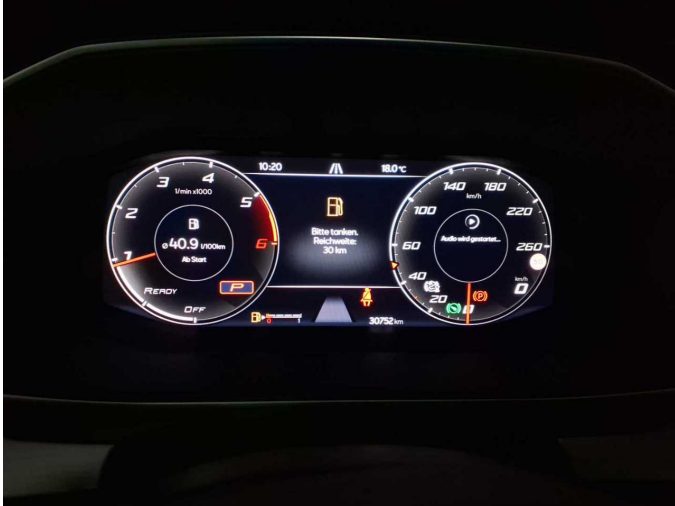
Figure 7: Instrument cluster

**Mileage (Read)** 30,752 km

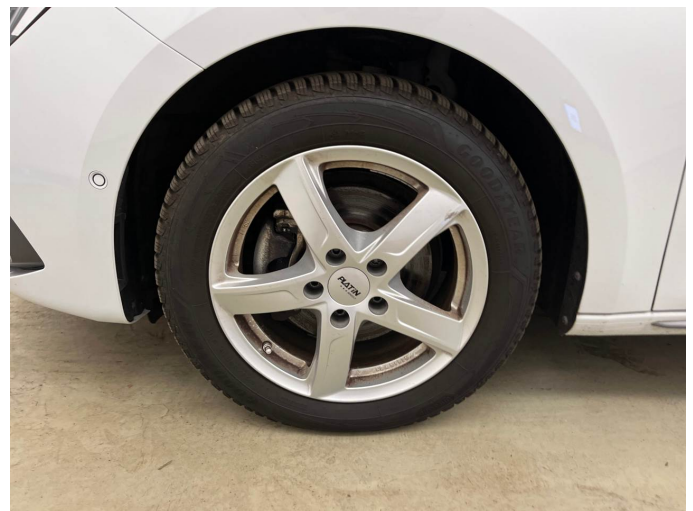
Figure 12: Mounted tyres

Mounted tyres				
#	Tyre size	Type of tyre	Manufacturer	Tread depth
1)	205/55 R16 91H	Winter tyres on Light alloy	Goodyear	5mm / 5mm
2)	205/55 R16 91H	Winter tyres on Light alloy	Goodyear	5mm / 5mm
Additional tyres				
#	Tyre size	Type of tyre	Manufacturer	Tread depth
1)	225/40 R18 92Y	Summer tyres on Light alloy	Bridgestone	5mm / 5mm
2)	225/40 R18 92Y	Summer tyres on Light alloy	Bridgestone	6mm / 6mm
Replacement				
Typ	Tyre size	Type of tyre	Manufacturer	Tread depth
N	125/70 R18 99M	Summer tyres on Steel	Sonstige	4 mm
