Expertise

Protocol number: 46695485  
Order No. / Reference: 26747179  
Inspection date: 21 Jul 2026

| Manufacturer: Opel | Model: Astra 1.5 D Start/Stop Sports Tourer Automatik Design&Tech |
| VIN: W0VBE8EV6N8044130 | |

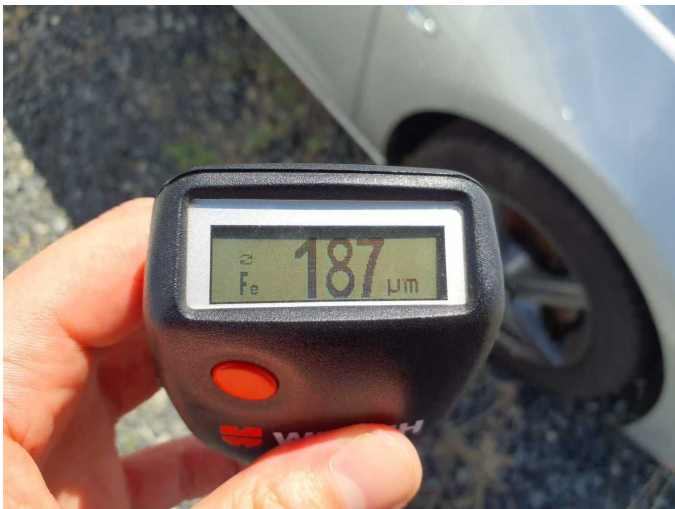
| No. | Repainting |
|---|---|
| 1 | Mudguard - right side, Professionally carried out, Invoice of repair done Non-existent |

**Repainting 1:** Mudguard - right side

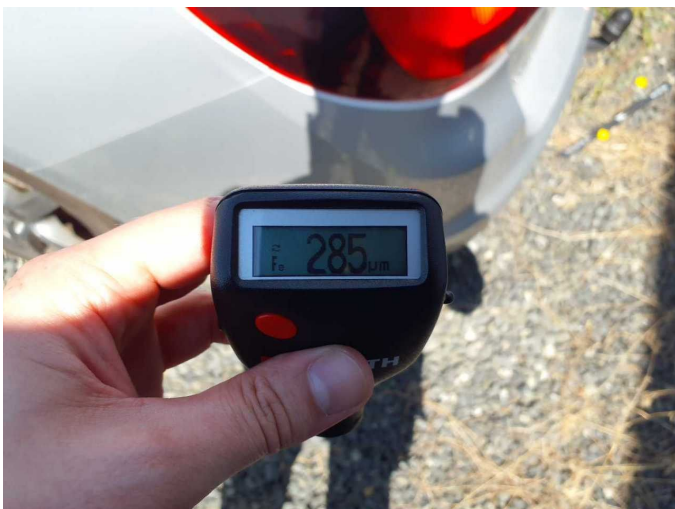
| No. | Repainting |
|---|---|
| 2 | Side panel - rear left side, Professionally carried out, Invoice of repair done Non-existent |

**Repainting 2:** Side panel - rear left side

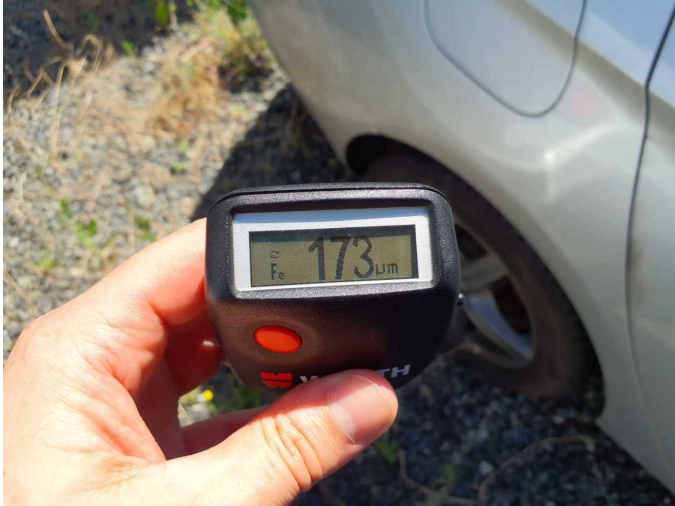
| No. | Repainting |
|---|---|
| 3 | Side panel - rear right side, Professionally carried out, Invoice of repair done Non-existent |

**Repainting 3:** Side panel - rear right side

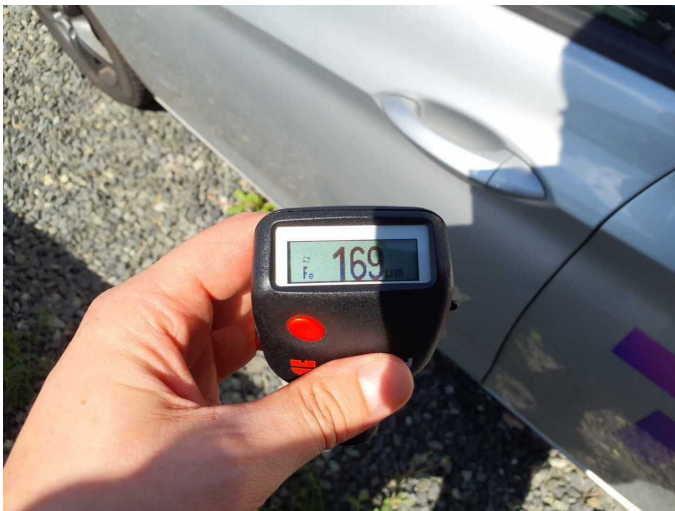
| No. | Repainting |
|---|---|
| 4 | Door - front left side, Professionally carried out, Invoice of repair done Non-existent |

**Repainting 4:** Door - front left side
