Expertise

Protocol number: 46635525  
Order No. / Reference: 26733581  
Inspection date: 15 Jul 2026

| Manufacturer: Opel | Model: Insignia Sports Tourer 2.0 Diesel Aut. Business |
| VIN: W0VZT8GP3N1004616 | |

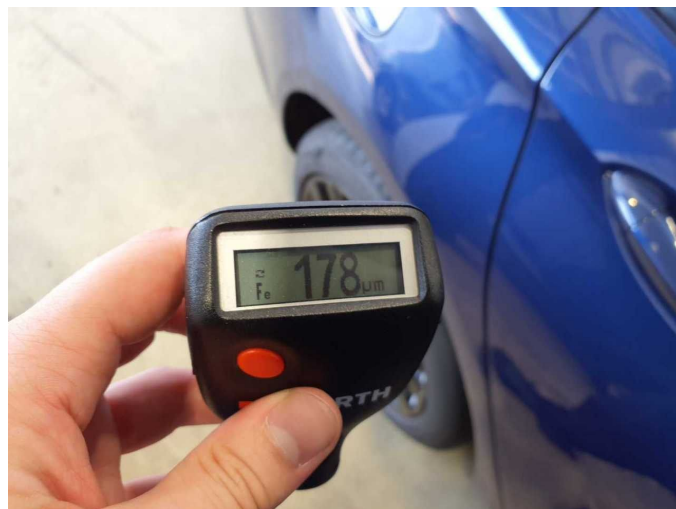
| No. | Component group | Description |
|---|---|---|
| 16 | Side panel - rear right side | Side panel (Spachtel rissig) - Unprofessionally repaired - Repair and paint |

| 1 | Side panel - rear right side, Unprofessionally carried out, Invoice of repair done Non-existent |

**Repainting 1:** Side panel - rear right side
