Expertise

Protocol number: 46393495
Order No. / Reference: 26642319
Inspection date: 8 Jul 2026

Manufacturer: Ford

Model: Transit Custom 280 L1H1 LKW VA Trend

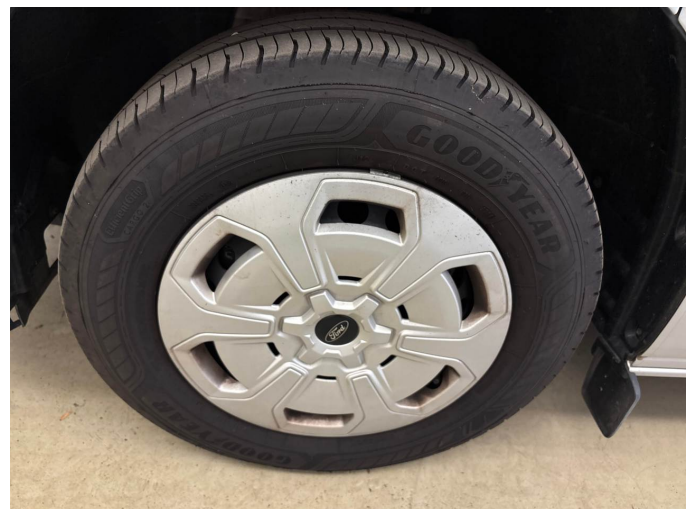
Figure 12: Mounted tyres

#	Tyre size	Type of tyre	Manufacturer	Tread depth
1)	215/65 R16 107T	Summer tyres on Steel rim with wheel cover	Goodyear	5mm / 5mm
2)	215/65 R16 107T	Summer tyres on Steel rim with wheel cover	Goodyear	5mm / 5mm
