Expertise

Protocol number: 45924105
Order No. / Reference: 26410548
Inspection date: 10 Jun 2026

Model: Astra 1.5 D Start/Stop Sports Tourer Automatik GS Line

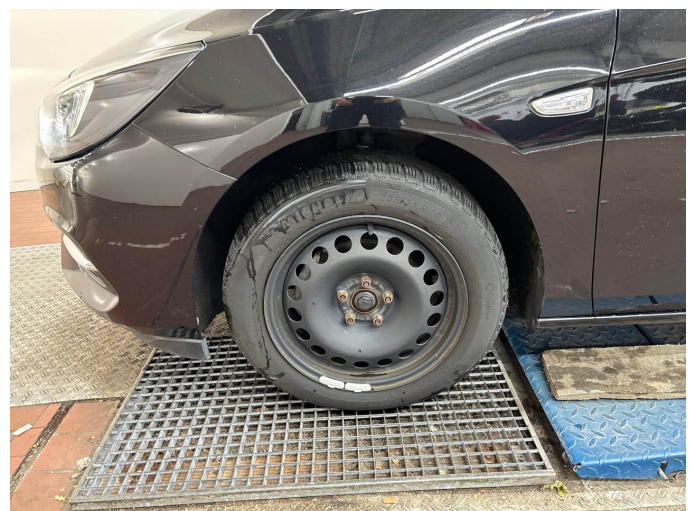
Figure 12: Mounted tyres

#	Tyre size	Type of tyre	Manufacturer	Tread depth
1)	205/55 R16 91H	Winter tyres on Steel	Michelin	4mm / 4mm
2)	205/55 R16 91H	Winter tyres on Steel	Michelin	4mm / 4mm

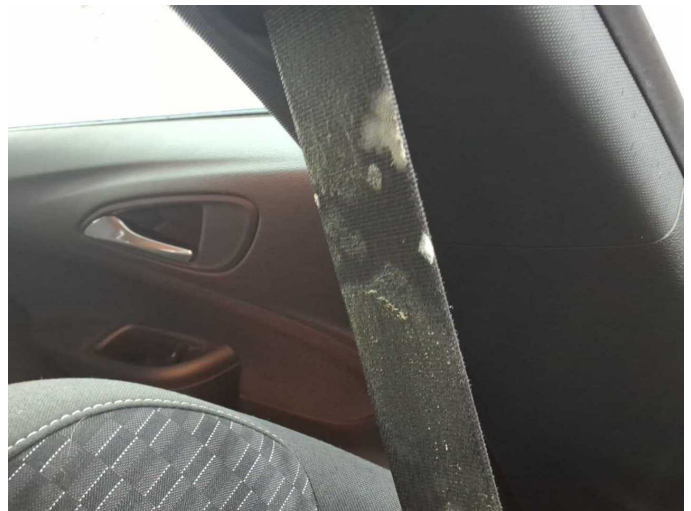
Damage 2: Seat belts - front: Seat belt - front left side - Soiled - Clean

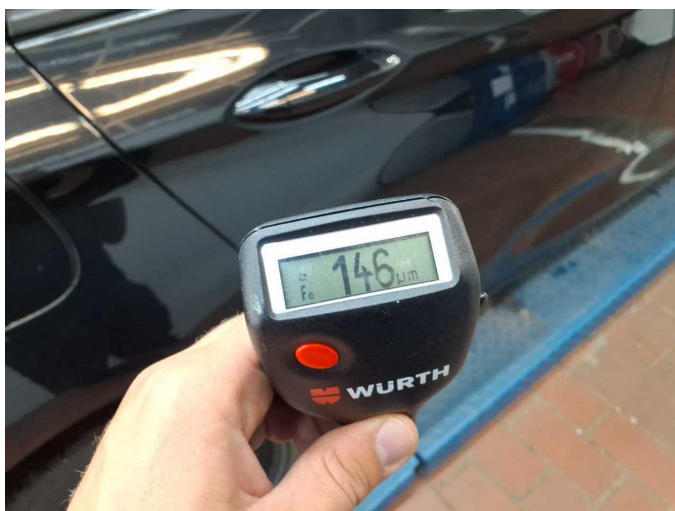
1	Side panel - rear right side, Door - rear right side, Professionally carried out, Invoice of repair done Non-existent
---	---

Repainting 1: Side panel - rear right side, Door - rear right side
