Expertise

Protocol number: 45850775
Order No. / Reference: 26529557
Inspection date: 8 Jun 2026

Model: Focus Turnier 1.5 EcoBlue Start-Stopp-System Aut. TITANIUM

VIN: WF0PXXGCHPPL83330

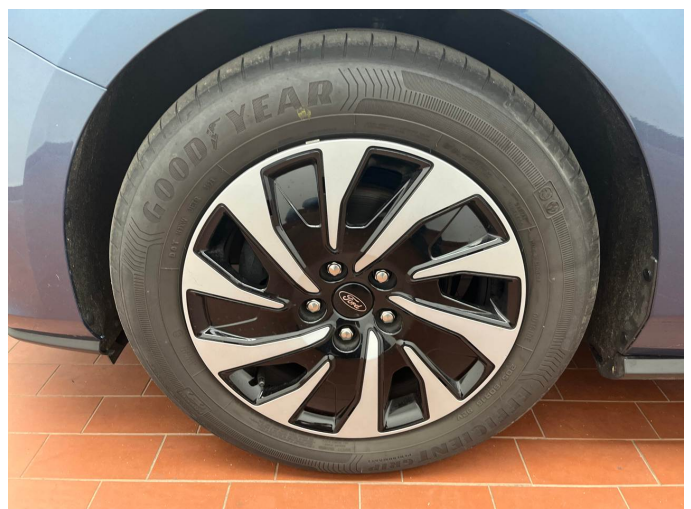
Figure 12: Mounted tyres

Mounted tyres				
#	Tyre size	Type of tyre	Manufacturer	Tread depth
1)	205/60 R16 92V	Summer tyres on Steel rim with wheel cover	Goodyear	3mm / 3mm
2)	205/60 R16 92V	Summer tyres on Steel rim with wheel cover	Goodyear	5mm / 5mm

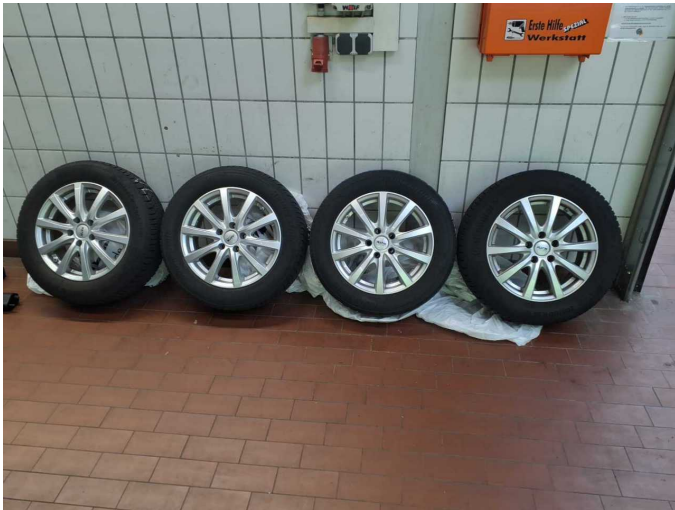
Figure 15: Additional tyres

Additional tyres				
#	Tyre size	Type of tyre	Manufacturer	Tread depth
1)	205/60 R16 92H	Winter tyres on Light alloy	Continental	7mm / 7mm
2)	205/60 R16 92H	Winter tyres on Light alloy	Bridgestone	0mm / 3mm
