## Expertise

Protocol number: 45793122  
Order No. / Reference: 26153222  
Inspection date: 2 Jun 2026

Model: 319 CDI Sprinter 4x4 Standard 9G-TRONIC PRO

VIN: W1V3MBTZ7TP849554

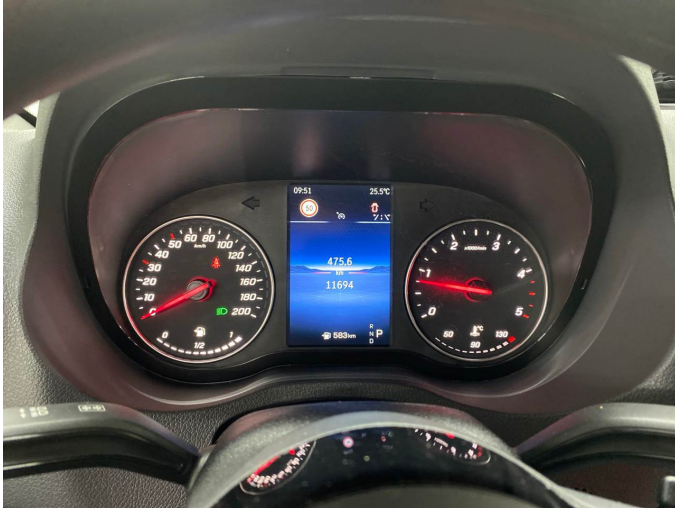
Figure 7: Instrument cluster

Documents submitted	At the time of the inspection, the vehicle registration certificate Part 2 (title) was available, but the vehicle registration certificate Part 1 (document) was not. (Copy)
VIN comparison	The vehicle identification number (VIN) was read from the vehicle and its conformity with the submitted documents was confirmed by the undersigned during the inspection.
Inspection	The inspection conditions were sufficient for the assessment of the vehicle. Lifting equipment and/or a pit were available for examining the vehicle.
Test drive	No test drive/shunting maneuver was carried out during the inspection of the vehicle.
Engine function test	An engine test run was performed, problem has been detected This is due to the following reason.: Motorkontrolle aktiv
