Expertise

Protocol number: 46193589
Order No. / Reference: 26559608
Inspection date: 29 Jun 2026

Manufacturer: CUPRA

Model: Born 150kW/58kWh

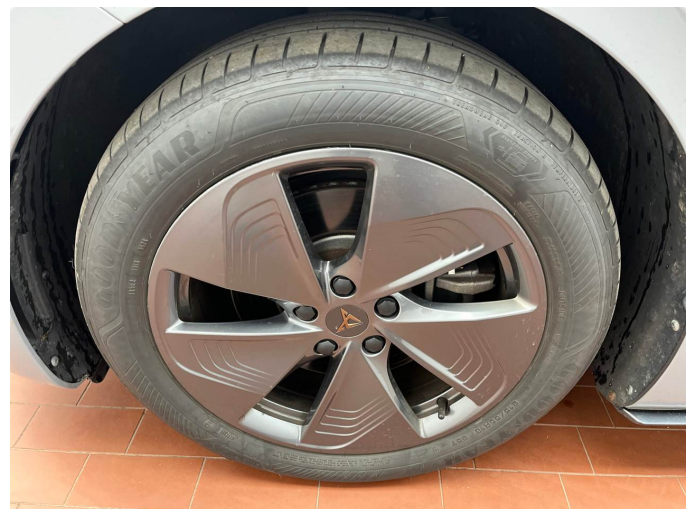
Figure 12: Mounted tyres

Mounted tyres				
#	Tyre size	Type of tyre	Manufacturer	Tread depth
1)	215/55 R18 95T	Summer tyres on Light alloy	Goodyear	5mm / 5mm
2)	215/55 R18 95T	Summer tyres on Light alloy	Goodyear	5mm / 5mm
Replacement				
Typ	Tyre size	Type of tyre	Manufacturer	Tread depth
	Tirefit	Expiration date 01/2028
