Expertise

Protocol number: 46134408
Order No. / Reference: 26510142
Inspection date: 23 Jun 2026

Manufacturer: Ford

Model: Transit Custom 300 L1H1 LKW VA Trail

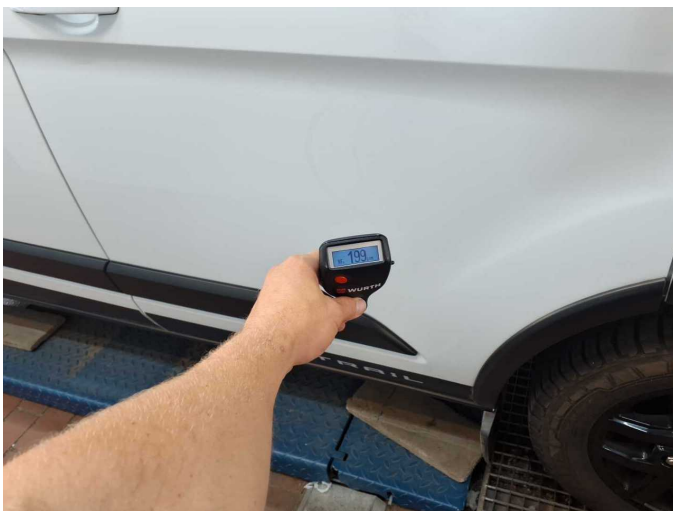
Repainting 1: Roof rail - right side, Mudguard - right side, Side panel - rear right side, Door - rear right side, Door - front right side

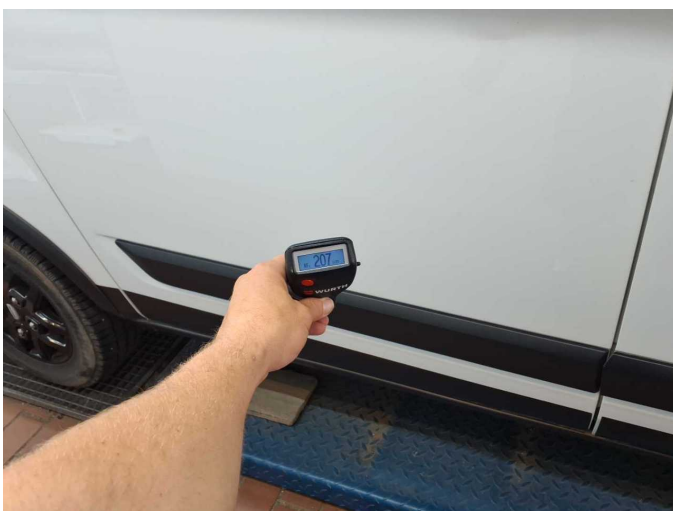
Repainting 1: Roof rail - right side, Mudguard - right side, Side panel - rear right side, Door - rear right side, Door - front right side

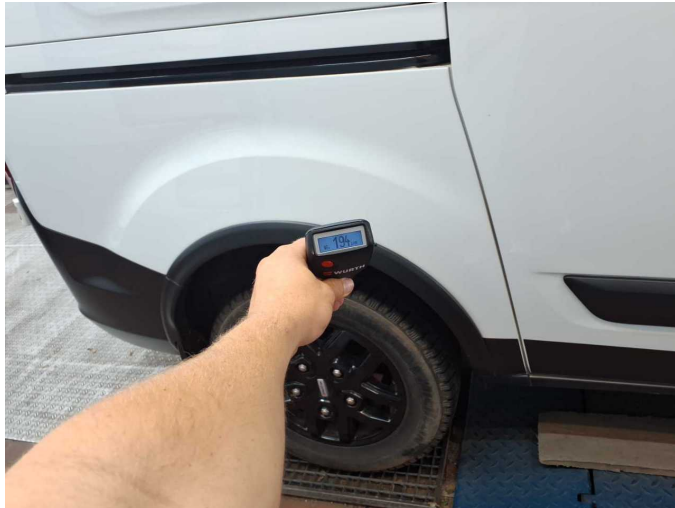
Repainting 1: Roof rail - right side, Mudguard - right side, Side panel - rear right side, Door - rear right side, Door - front right side

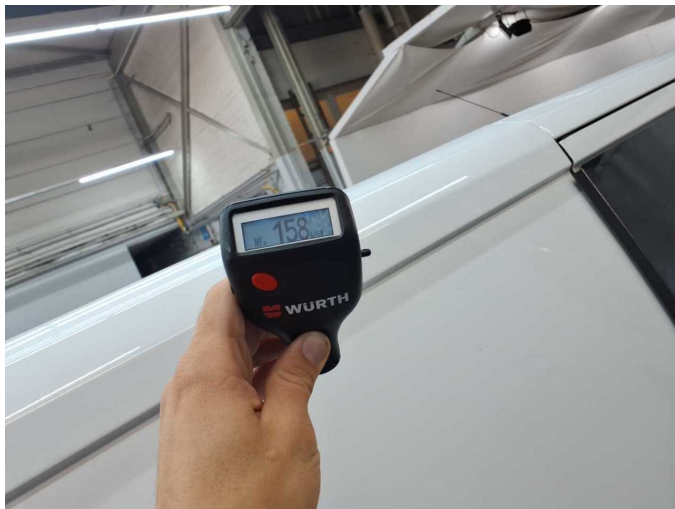
Repainting 1: Roof rail - right side, Mudguard - right side, Side panel - rear right side, Door - rear right side, Door - front right side
