Expertise

Protocol number: 46352680
Order No. / Reference: 26545161
Inspection date: 1 Jul 2026

Manufacturer: Seat

Model: Arona 1.0 TSI OPF Xperience

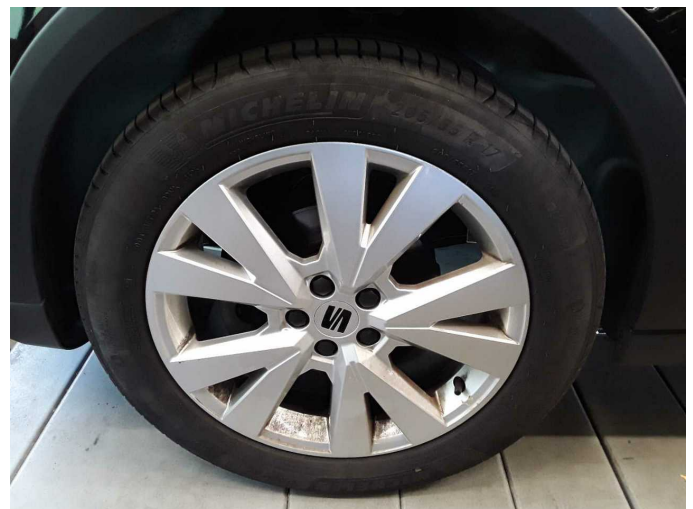
Figure 12: Mounted tyres

Mounted tyres			
#	Tyre size	Type of tyre	Tread depth
1)	205/55 R17 91W	Summer tyres on Light alloy	4mm / 4mm
2)	205/55 R17 91W	Summer tyres on Light alloy	4mm / 4mm
