Expertise

Protocol number: 45826322
Order No. / Reference: 26417361
Inspection date: 5 Jun 2026

Manufacturer: Renault

Model: Kangoo Rapid Blue dCi 75 Extra

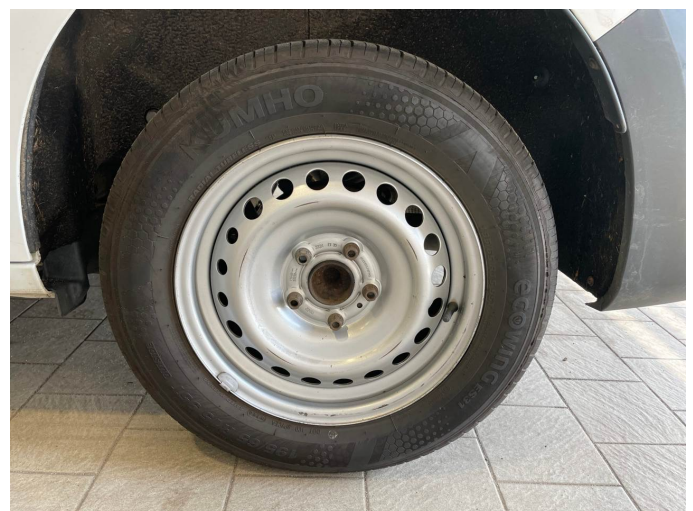
Figure 12: Mounted tyres

#	Tyre size	Type of tyre	Manufacturer	Tread depth
1)	195/65 R15 95T	Summer tyres on Steel	Kumho	5mm / 5mm
2)	195/65 R15 95T	Summer tyres on Steel	Kumho	7mm / 7mm
