Expertise

Protocol number: 46575792  
Order No. / Reference: 26739240  
Inspection date: 14 Jul 2026

Manufacturer: Volkswagen

Model: Touran 2.0 TDI SCR DSG Comfortline

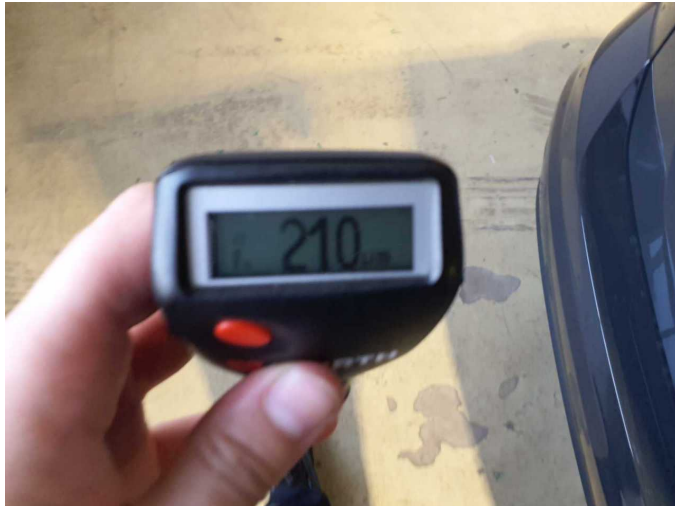
| No. | Repainting |
|---|---|
| 1 | Boot lid / rear door, Professionally carried out, Invoice of repair done Non-existent |

**Repainting 1:** Boot lid / rear door

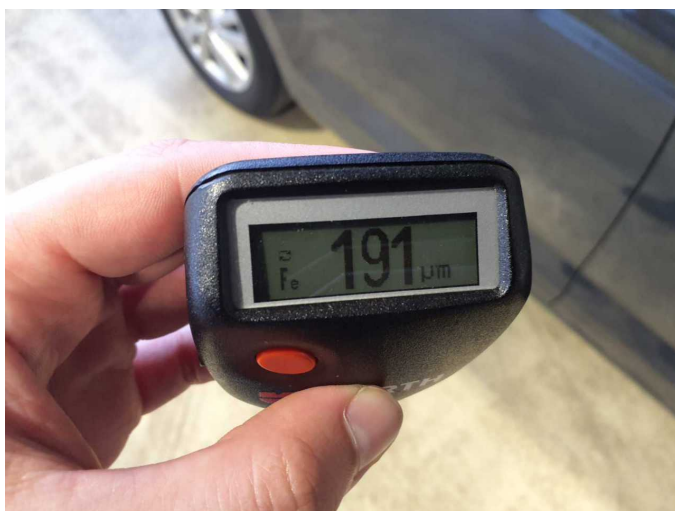
| No. | Repainting |
|---|---|
| 3 | Door - rear right side, Professionally carried out, Invoice of repair done Non-existent |

**Repainting 3:** Door - rear right side

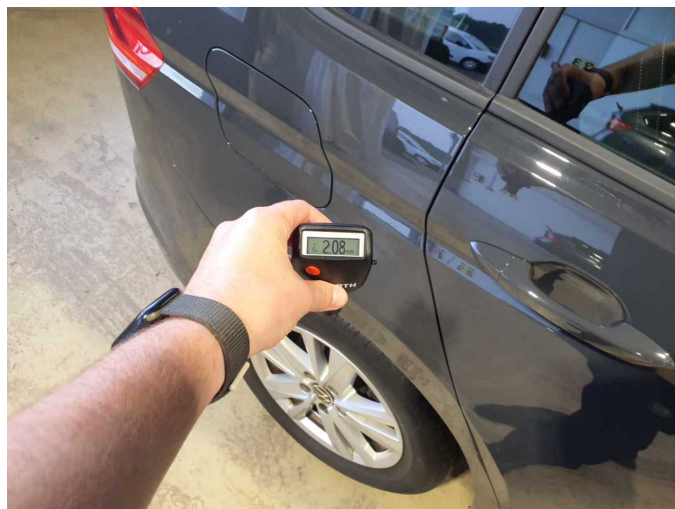
| No. | Repainting |
|---|---|
| 5 | Side panel - rear right side, Unprofessionally carried out, Invoice of repair done Non-existent |

**Repainting 5:** Side panel - rear right side
