Expertise

Protocol number: 46881945  
Order No. / Reference: 26782872  
Inspection date: 4 Aug 2026

Manufacturer: Opel

Model: Astra 1.5 D Start/Stop Sports Tourer Elegance

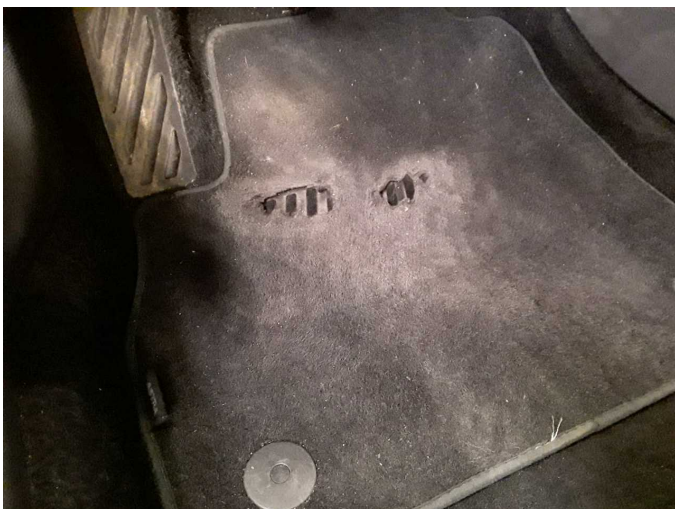
| No. | Component group | Description |
|---|---|---|
| 1 | Trim / covers | Floor mats - Broken / torn - Replace |

Damage 1: Trim / covers: Floor mats - Broken / torn - Replace
