Expertise

Protocol number: 46460485  
Order No. / Reference: 26577733  
Inspection date: 10 Jul 2026

Model: Zafira Life 2.0 D M Aut. Tourer

VIN: VXEEVHZ7NZ010644

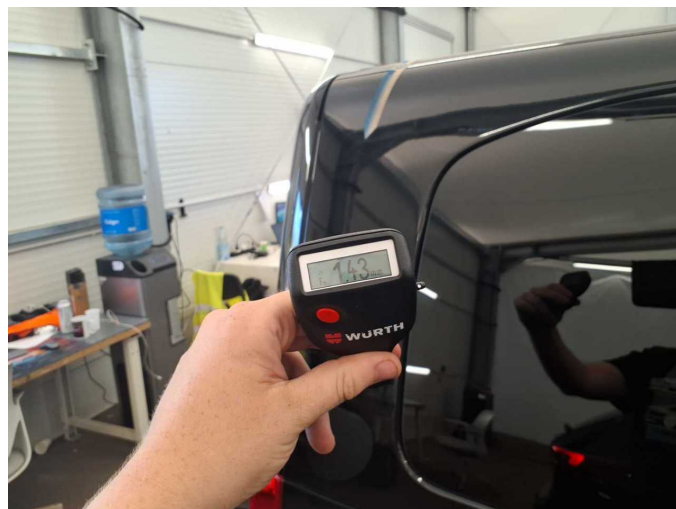
**Repainting 1:** Side panel - rear right side
