Expertise

Protocol number: 46371487  
Order No. / Reference: 26534020-1  
Inspection date: 30 Jun 2026

Manufacturer: Opel

Model: Zafira Life 2.0 D M Aut. Elegance

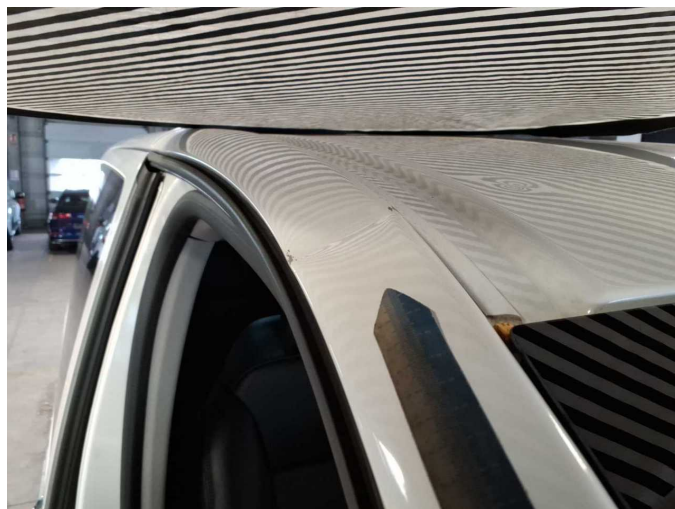
**Damage 20:** Body: A-pillar - right side - Deformed - Paint
