Expertise

Protocol number: 45606042
Order No. / Reference: 26284736
Inspection date: 12 May 2026

Manufacturer: Skoda

Model: Kodiaq 2.0 TDI 4x4 DSG Sportline

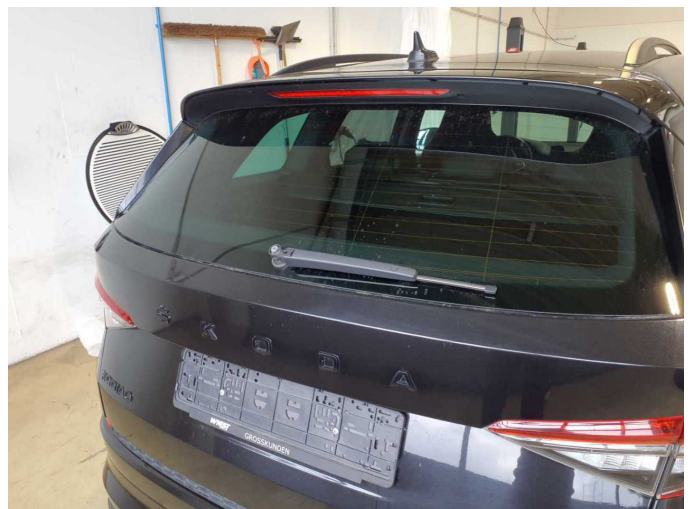
| No. | Component group | Description |
|---|---|---|
| 1 | Screen cleaning | Wiper arm - rear (Abdeckkappe) - Missing - Replace |

Damage 1: Screen cleaning: Wiper arm - rear (Abdeckkappe) - Missing - Replace
