Expertise

Protocol number: 46171143
Order No. / Reference: 26530177
Inspection date: 24 Jun 2026

Manufacturer: Volkswagen

Model: T7 Multivan 2,0 TDI SCR Kurz Life

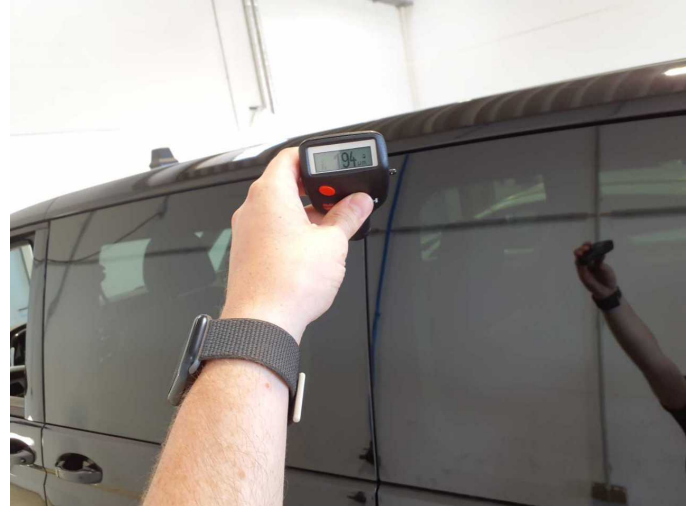
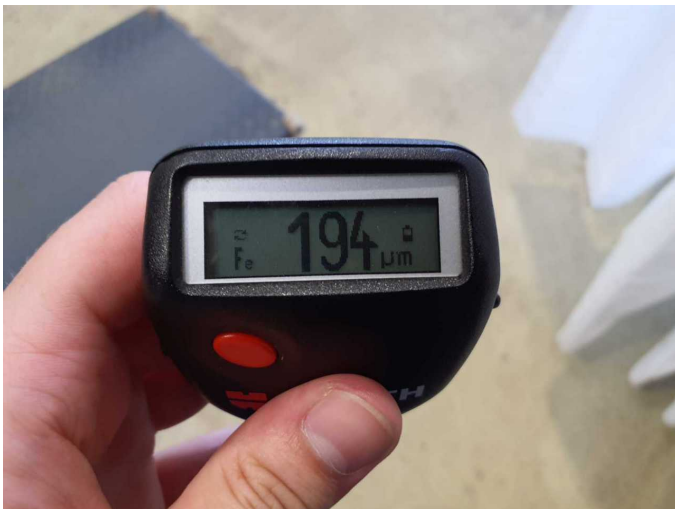
Repainting 2: Roof rail - left side

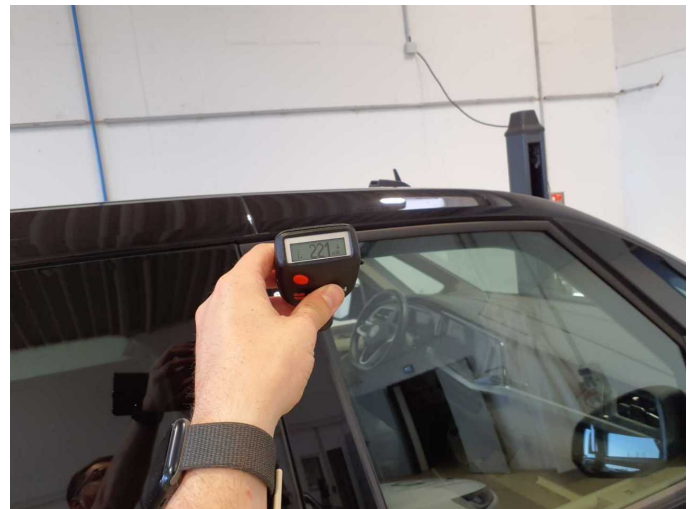
Repainting 3: Roof rail - right side

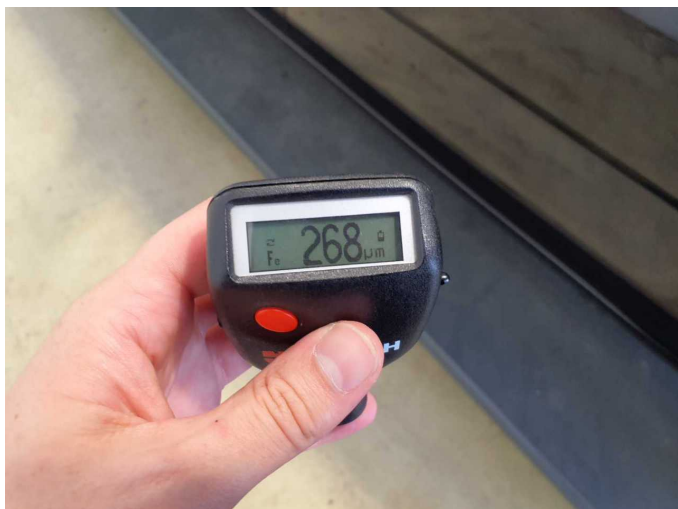
Repainting 4: Door - rear left side

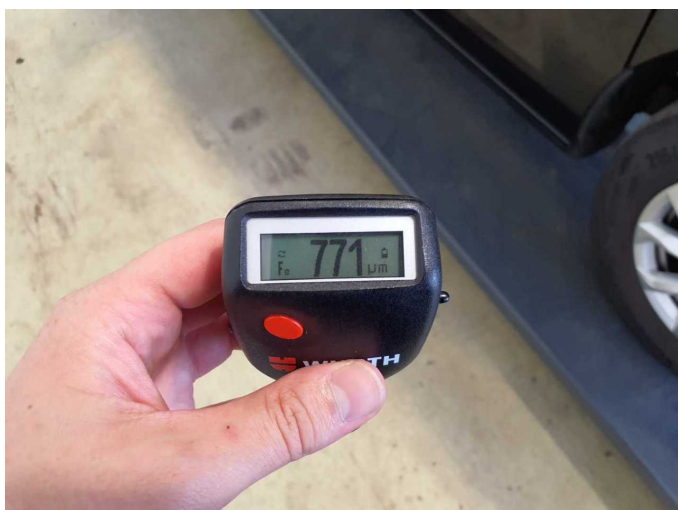
Repainting 5: Side panel - rear left side
