## Expertise

Protocol number: 46164297  
Order No. / Reference: 26469639  
Inspection date: 24 Jun 2026

Manufacturer: Ford

Model: Transit 350 L3H2 Lkw VA Autm. Trend

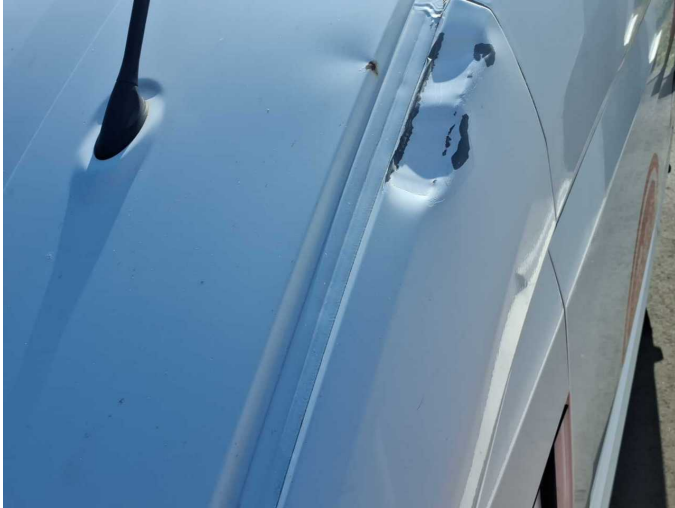
**Accident 2: Roof, Front**

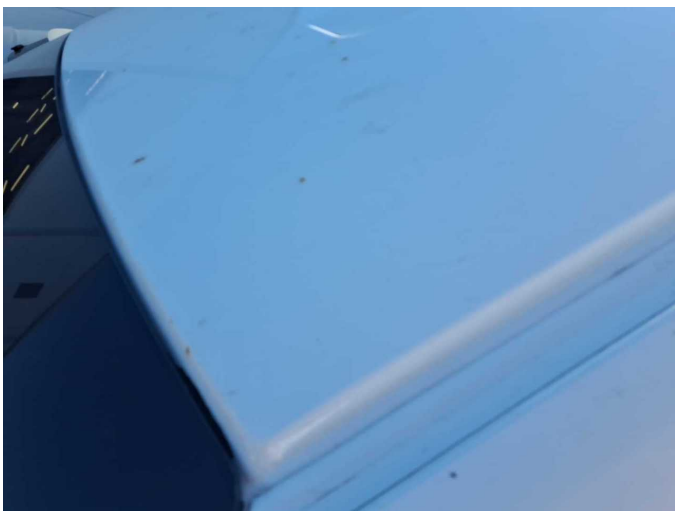
**Accident 2: Roof, Front**

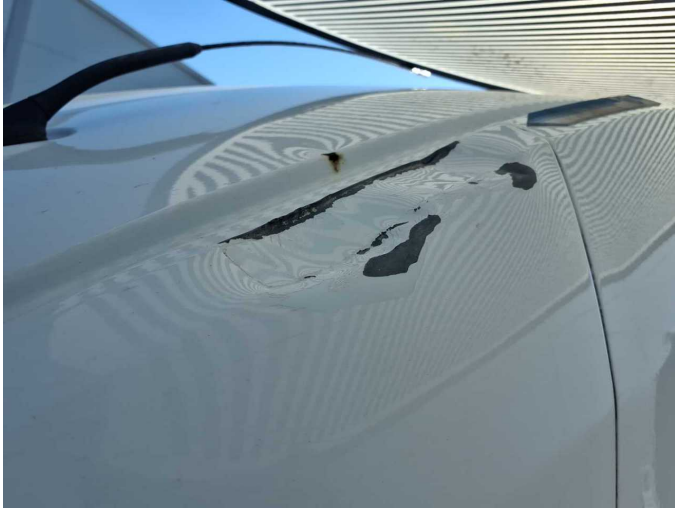
**Accident 2: Roof, Front**

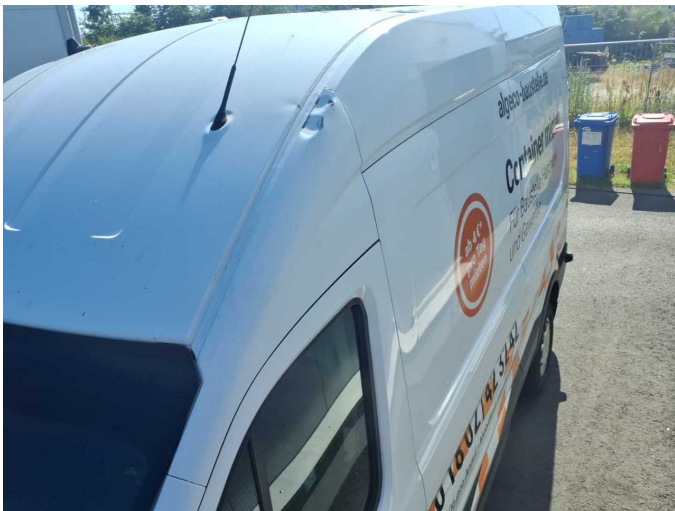
**Accident 2: Roof, Front**

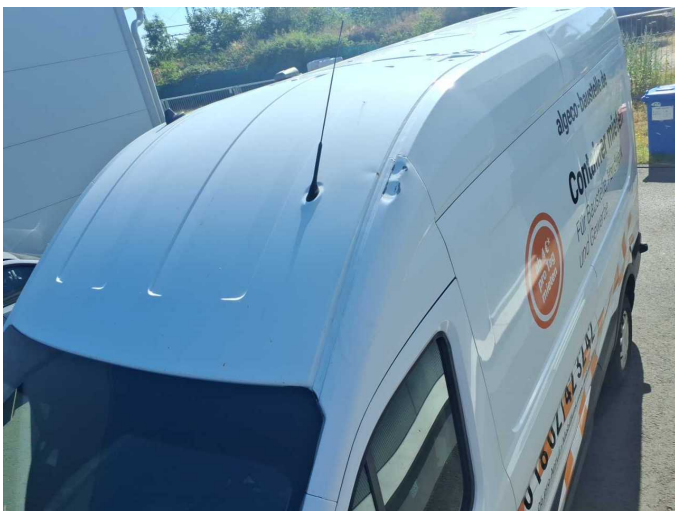
**Accident 2: Roof, Front**
