Expertise

Protocol number: 45522208
Order No. / Reference: 26382962
Inspection date: 13 May 2026

Manufacturer: Opel

Model: Astra Sports Tourer 1.5 D Automatik Business Edition

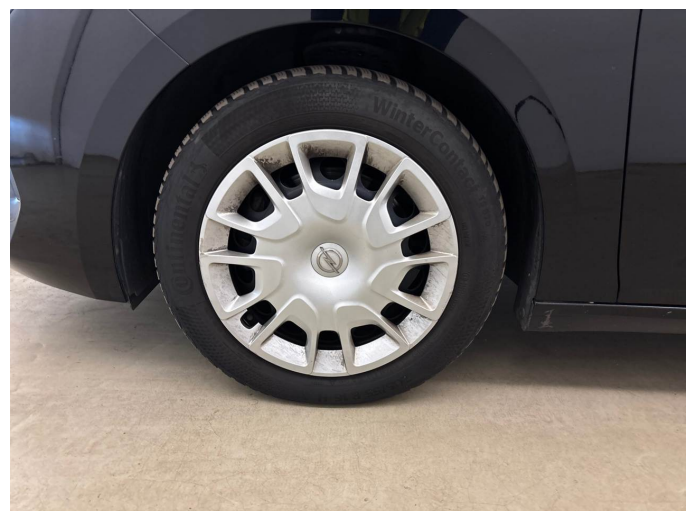
Figure 12: Mounted tyres

Mounted tyres			
#	Tyre size	Type of tyre	Tread depth
1)	205/55 R16 91H	Winter tyres on Steel rim with wheel cover	3mm / 3mm
2)	205/55 R16 91H	Winter tyres on Steel rim with wheel cover	5mm / 5mm

Der montierte Winterradsatz ist kein Bestandteil der Ausstattung.

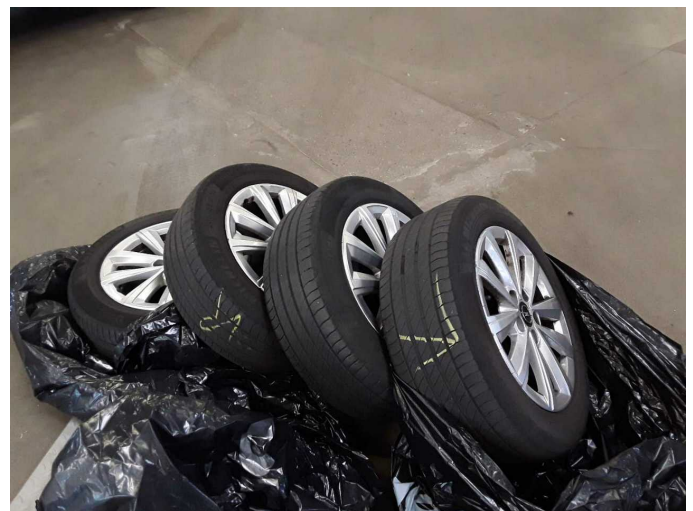
Figure 16: Additional tyres

Additional tyres			
#	Tyre size	Type of tyre	Tread depth
1)	205/55 R16 94V	Summer tyres on Light alloy	4mm / 4mm
2)	205/55 R16 94V	Summer tyres on Light alloy	5mm / 5mm
