Expertise

Protocol number: 46447845  
Order No. / Reference: 26028744  
Inspection date: 8 Jul 2026

Manufacturer: Mercedes-Benz

Model: Vito 116 CDI Lang HA Aut. PRO Kasten

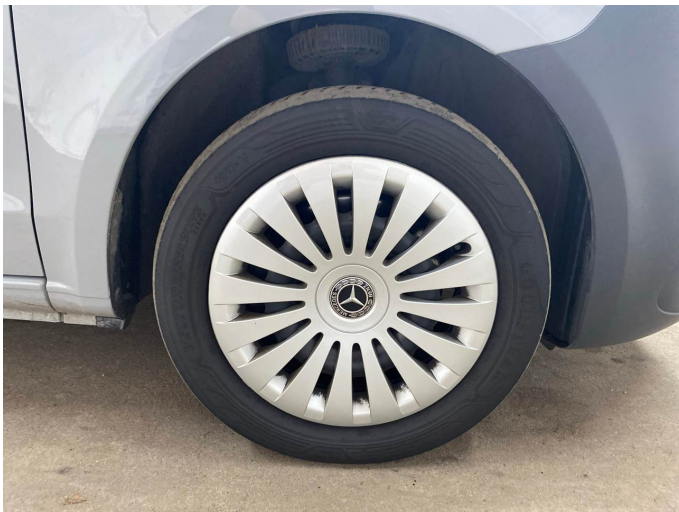
Figure 12: Mounted tyres

| No. | Component group | Description |
|---|---|---|
| 2 | Wheel / tyres | Tyres - complete set - Worn - Replace |
