Expertise

Protocol number: 46146189
Order No. / Reference: 26521554
Inspection date: 24 Jun 2026

Manufacturer: Peugeot

Model: 3008 BlueHDi 130 Stop & Start Active Business-Paket

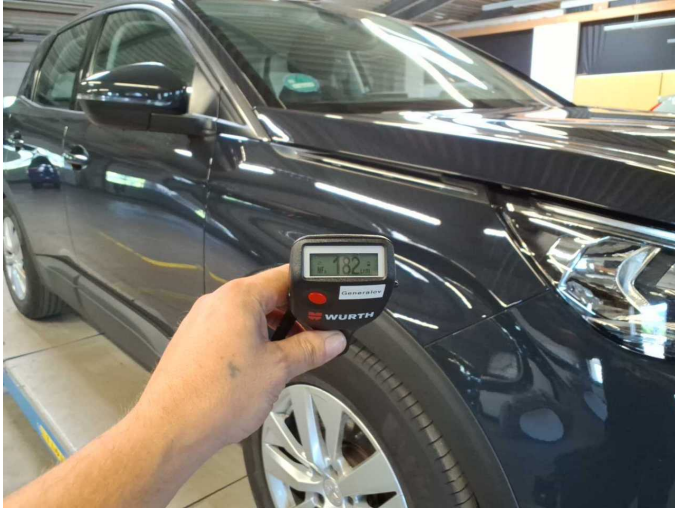
Repainting 3: Mudguard - right side

- 1 Roof, Professionally carried out, Invoice of repair done Non-existent
- 2 Mudguard - left side, Professionally carried out, Invoice of repair done Non-existent
- 3 Mudguard - right side, Professionally carried out, Invoice of repair done Non-existent
- 4 Bonnet, Professionally carried out, Invoice of repair done Non-existent
- 5 Side panel - rear left side, Professionally carried out, Invoice of repair done Non-existent
- 6 Side panel - rear right side, Professionally carried out, Invoice of repair done Non-existent
- 7 Door - rear left side, Professionally carried out, Invoice of repair done Non-existent
- 8 Door - rear right side, Professionally carried out, Invoice of repair done Non-existent
- 9 Door - front left side, Professionally carried out, Invoice of repair done Non-existent
- 10 Door - front right side, Professionally carried out, Invoice of repair done Non-existent
