Expertise

Protocol number: 46589179  
Order No. / Reference: 26678705  
Inspection date: 20 Jul 2026

Manufacturer: Volkswagen

Model: Transporter T6.1 DSG Kurz

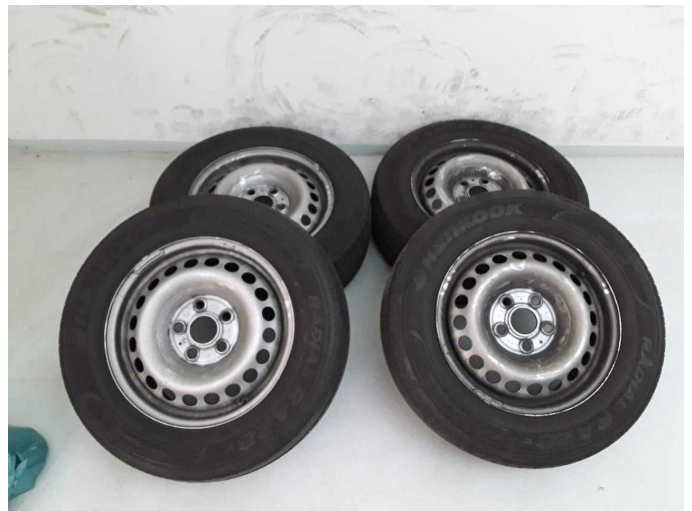
Figure 16: Additional tyres

| No. | Component group | Description |
|---|---|---|
| 6 | 2nd wheel set | 2 tyres - Worn - Replace |
