## Expertise

Protocol number: 46359267  
Order No. / Reference: 26547160  
Inspection date: 3 Jun 2026

Manufacturer: Peugeot

Model: 5008 BlueHDi 130 EAT8 GT

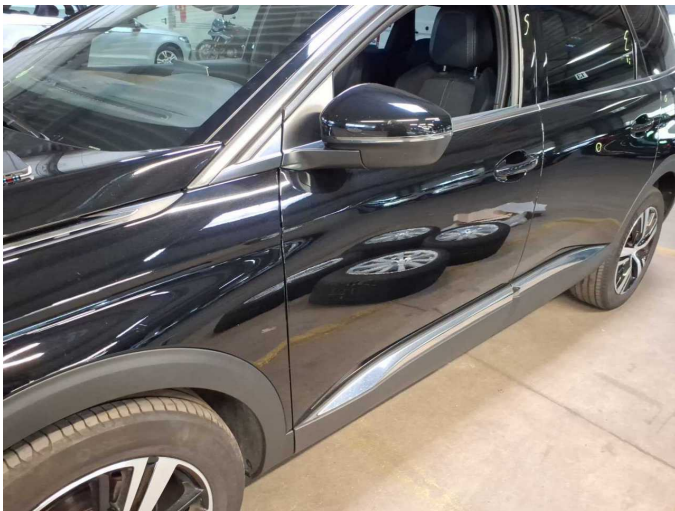
No.	Repainting
1	Door - front left side, Professionally carried out, Invoice of repair done Non-existent

Repainting 1: Door - front left side
