Expertise

Protocol number: 45125600
Order No. / Reference: 26292985
Inspection date: 24 Apr 2026

Model: 317 CDI Sprinter Standard HA 9G-TRONIC PRO

VIN: W1V3KBFZ1TP863645

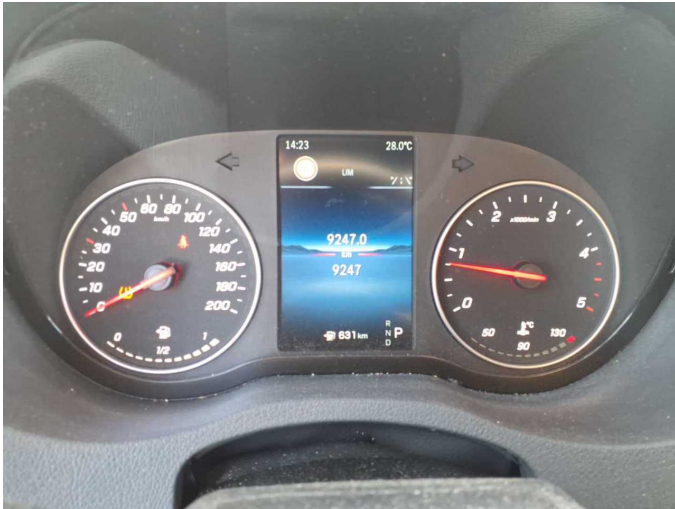
Figure 7: Instrument cluster

Damage 1: Instrument panel: Indicator light (Reifendruckkontrolle) - on - Perform diagnosis
