Expertise

Protocol number: 46516491  
Order No. / Reference: 26652071  
Inspection date: 1 Jul 2026

Manufacturer: Seat

Model: Cupra Leon Sportstourer 1.4 e-Hybrid (150 kW System)

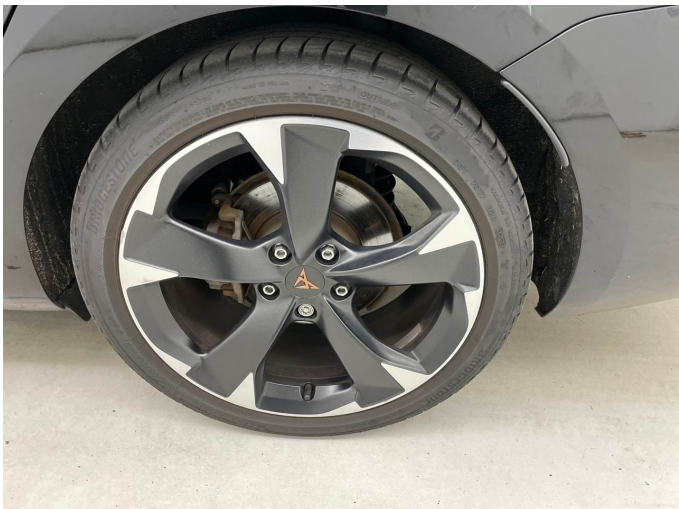
Figure 12: Mounted tyres

| No. | Component group | Description |
|---|---|---|
| 12 | Wheel / tyres | Tyre - rear right side (nicht fahrbereit) - Damaged - Replace |

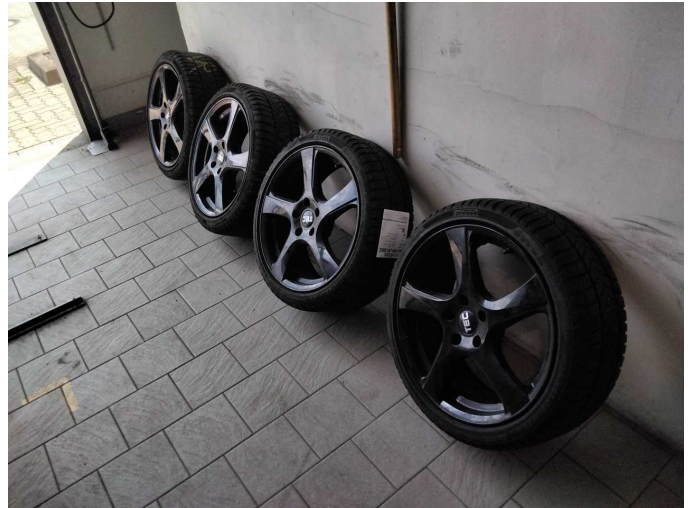
Figure 14: Additional tyres

Damage 1: 2nd wheel set: 1 tyre (Platt) - Perform diagnosis
