Expertise

Protocol number: 46068120
Order No. / Reference: 26520730
Inspection date: 22 Jun 2026

Manufacturer: Seat

Model: Born 150kW/58kWh

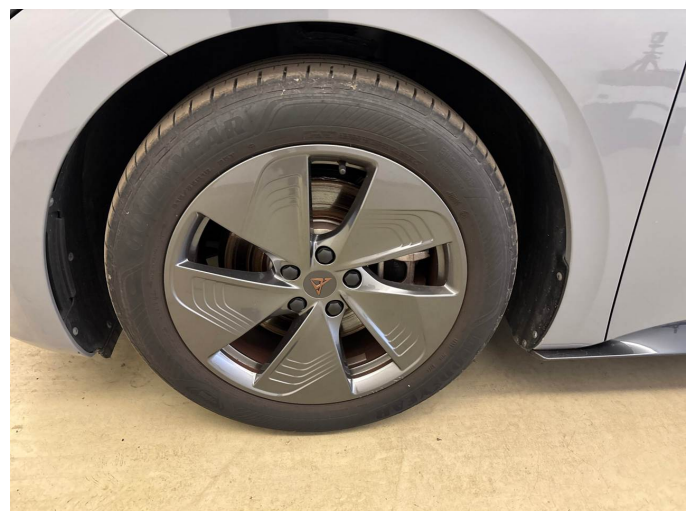
Figure 12: Mounted tyres

#	Tyre size	Type of tyre	Manufacturer	Tread depth
1)	215/55 R18 95T	Summer tyres on Light alloy	Goodyear	4mm / 4mm
2)	215/55 R18 95T	Summer tyres on Light alloy	Goodyear	4mm / 4mm
