Expertise

Protocol number: 46360171
Order No. / Reference: 26490095
Inspection date: 6 Jul 2026

Manufacturer: Ford

Model: Kuga 2.5 Duratec FHEV TITANIUM

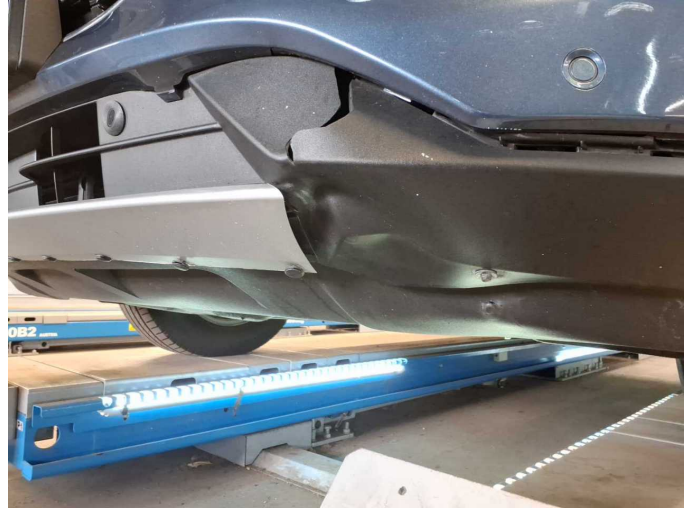
Accident 1: Front, Side - left
