Expertise

Protocol number: 46023491
Order No. / Reference: 26461114
Inspection date: 18 Jun 2026

Manufacturer: Ford

Model: Transit Connect 220 L1 S&S Trend

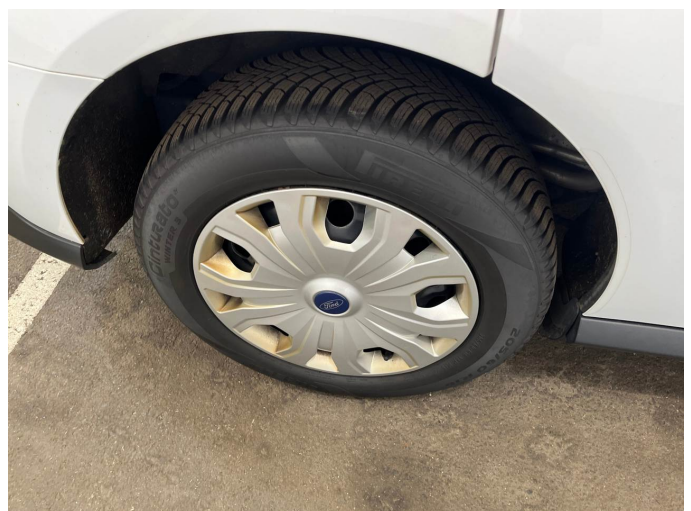
Figure 12: Mounted tyres

#	Tyre size	Type of tyre	Manufacturer	Tread depth
1)	205/60 R16 96H	Winter tyres on Steel rim with wheel cover	Pirelli	5mm / 5mm
2)	205/60 R16 96H	Winter tyres on Steel rim with wheel cover	Pirelli	7mm / 7mm
