Expertise

Protocol number: 46749207  
Order No. / Reference: 26740797  
Inspection date: 28 Jul 2026

| Manufacturer: Opel | Model: Insignia Sports Tourer 2.0 Diesel Aut. Elegance |

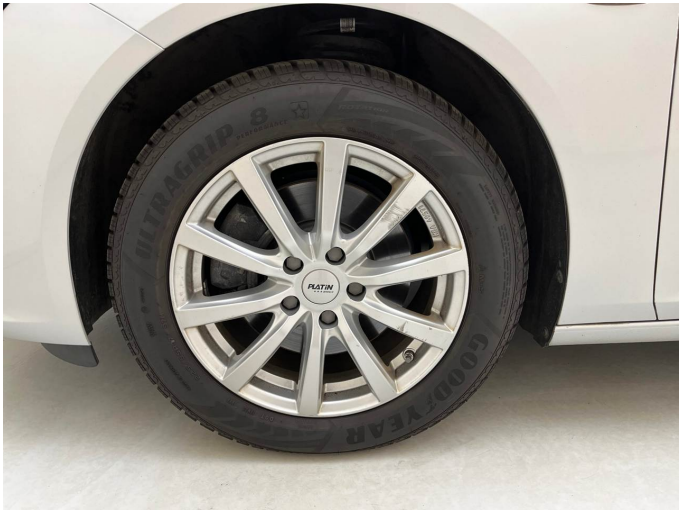
Figure 12: Mounted tyres

- Für den montierten Radsatz wurde kein Nachweis erbracht.
- Winterradsatz ist kein Bestandteil des Auslieferungsumfangs.
