Expertise

Protocol number: 45555222
Order No. / Reference: 26316813
Inspection date: 8 May 2026

Model: Astra 1.5 D Start/Stop Sports Tourer Automatik Edition

VIN: W0VBD8EV2N8031989

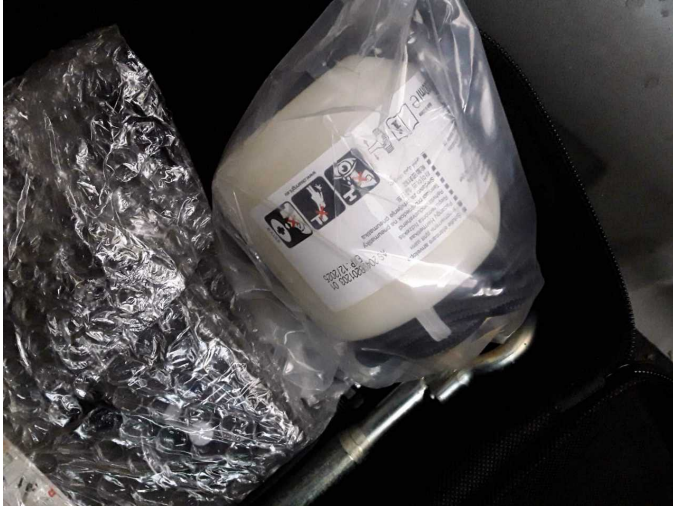
Damage 1: Equipment: Tirefit filler - Due - Replace

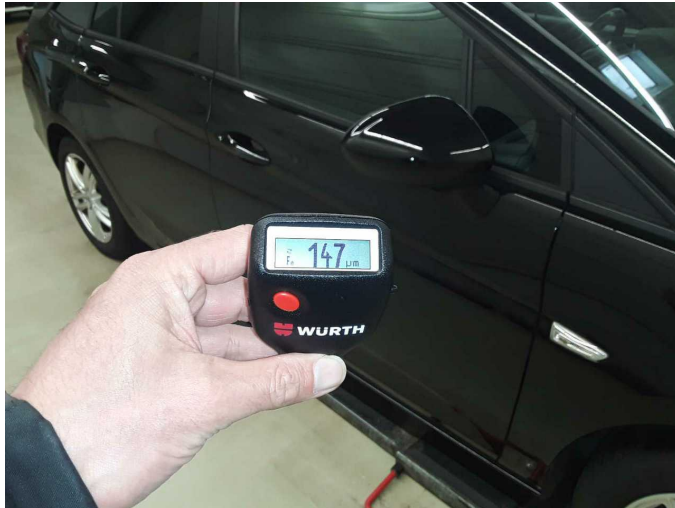
No.	Repainting
1	Mudguard - right side, Side panel - rear right side, Door - rear right side, Door - front right side, Professionally carried out, Invoice of repair done Non-existent

Repainting 1: Mudguard - right side, Side panel - rear right side, Door - rear right side, Door - front right side

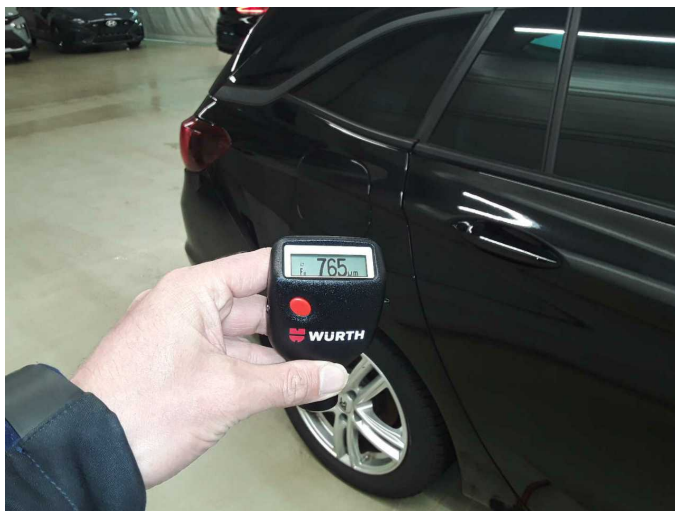
Repainting 1: Mudguard - right side, Side panel - rear right side, Door - rear right side, Door - front right side
