Expertise

Protocol number: 46607899  
Order No. / Reference: 26688208  
Inspection date: 20 Jul 2026

Manufacturer: Ford

Model: Grand Tourneo Connect 2.0 EcoBlue TITANIUM

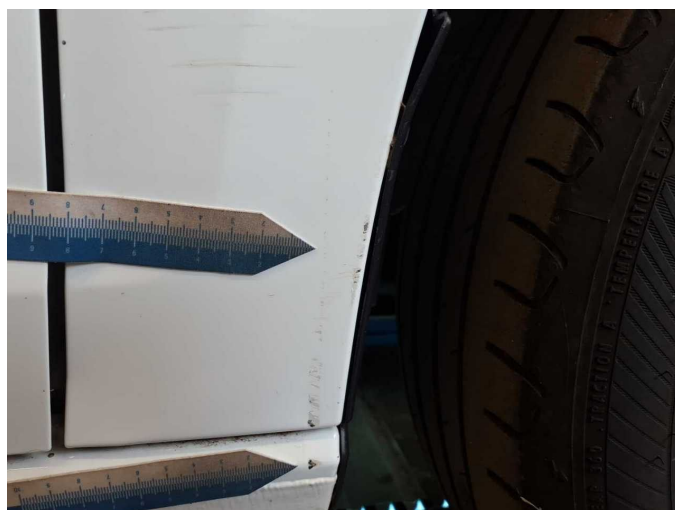
| No. | Component group | Description |
|---|---|---|
| 6 | Sill - right side | Sill - Deformed - Repair and paint |

**Accident 1: Side right**
