## Expertise

Protocol number: 45926602  
Order No. / Reference: 26490045  
Inspection date: 11 Jun 2026

Manufacturer: Opel

Model: Vivaro 1.5 D L

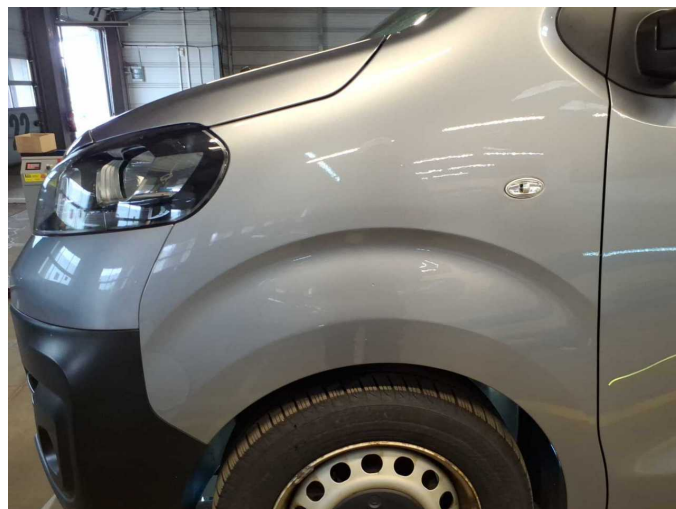
1 Mudguard - left side, Professionally carried out, Invoice of repair done Non-existent

Repainting 1: Mudguard - left side

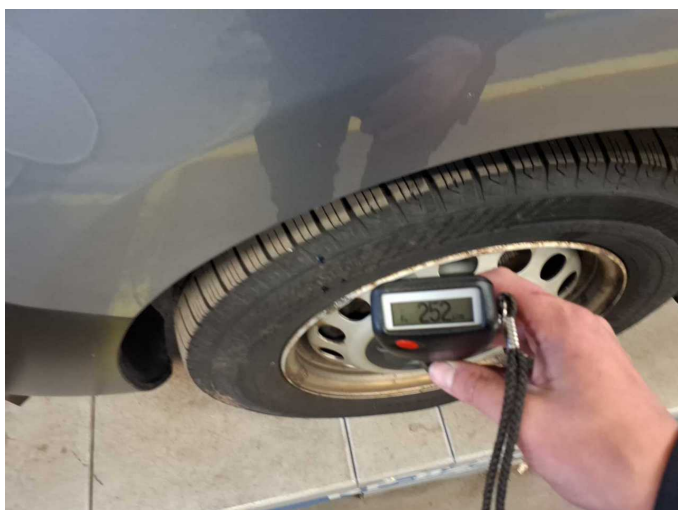
Mudguard - left side: 252  $\mu\text{m}$
